**OAK CREEK WATERSHED**  
**STREAM STABILITY ASSESSMENT AND RESTORATION**  
**RECOMMENDATIONS REPORT**

**INYO NATIONAL FOREST**

**Prepared by USFS Hydrologist Craig Oehrli**

**August 2015**

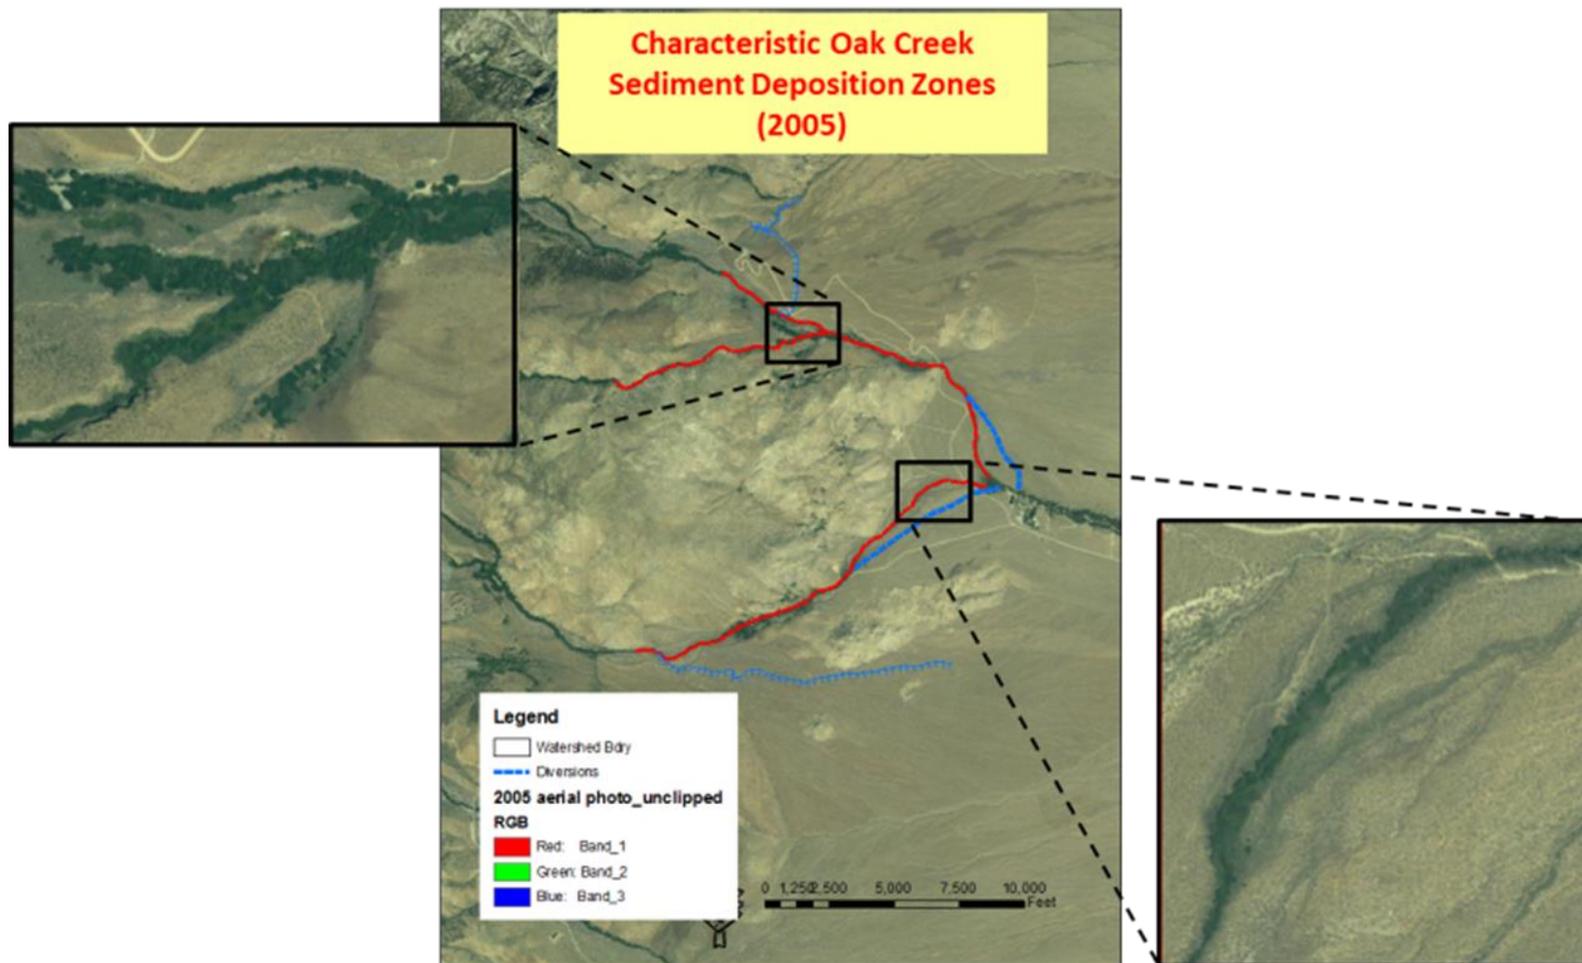
- **No evidence of incision on any of three forks**
- **Nearly contiguous robust riparian vegetative cover along stream banks and adjacent, hydrologically connected, fan surfaces**
- **No evidence of stream bed instability indicators (braiding or large bar deposits)**

**FIGURE 2 – Photo of the pre fire-flood Oak Creek analysis areas with zoomed in photos of depositional zones on the south fork and north/middle fork confluence areas. These depositional zones are wider than other sections of stream and would tend to show a response (heavy bar formation or braiding indicative of an excessive sediment input) if instability was occurring upstream.**

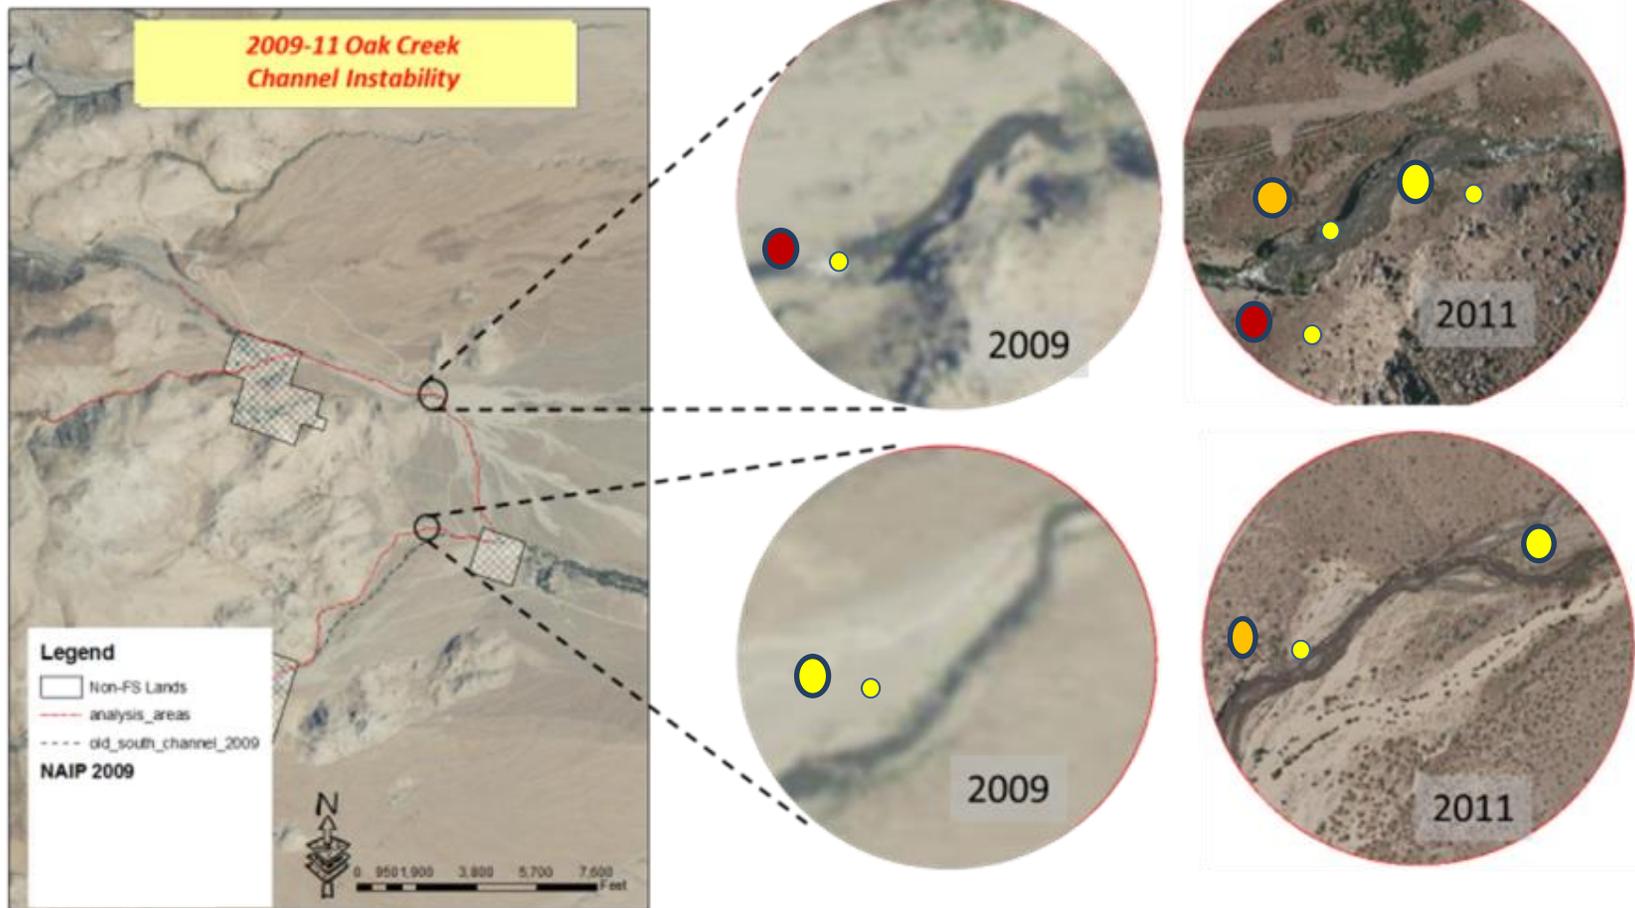
- **Visible head cutting of the channel bed on all three forks**
- **Wide spread cut bank erosion and almost no stream bank vegetation present 2009 with just a small increase in stream bank vegetation by 2011**
- **Channel sections with a braided flow pattern on portions all three forks**

FIGURE 3 – Location and images of characteristic channel instability on the North and South Fork Oak Creek. Close up Images downloaded and clipped from ArcGIS Online World Imagery at a 1:3000 scale. Photos display braiding (yellow circle), bank erosion (orange circle), and streambed head cutting (red circle) indicative of an unstable stream conditions typical of that identified on all three forks of Oak Creek.

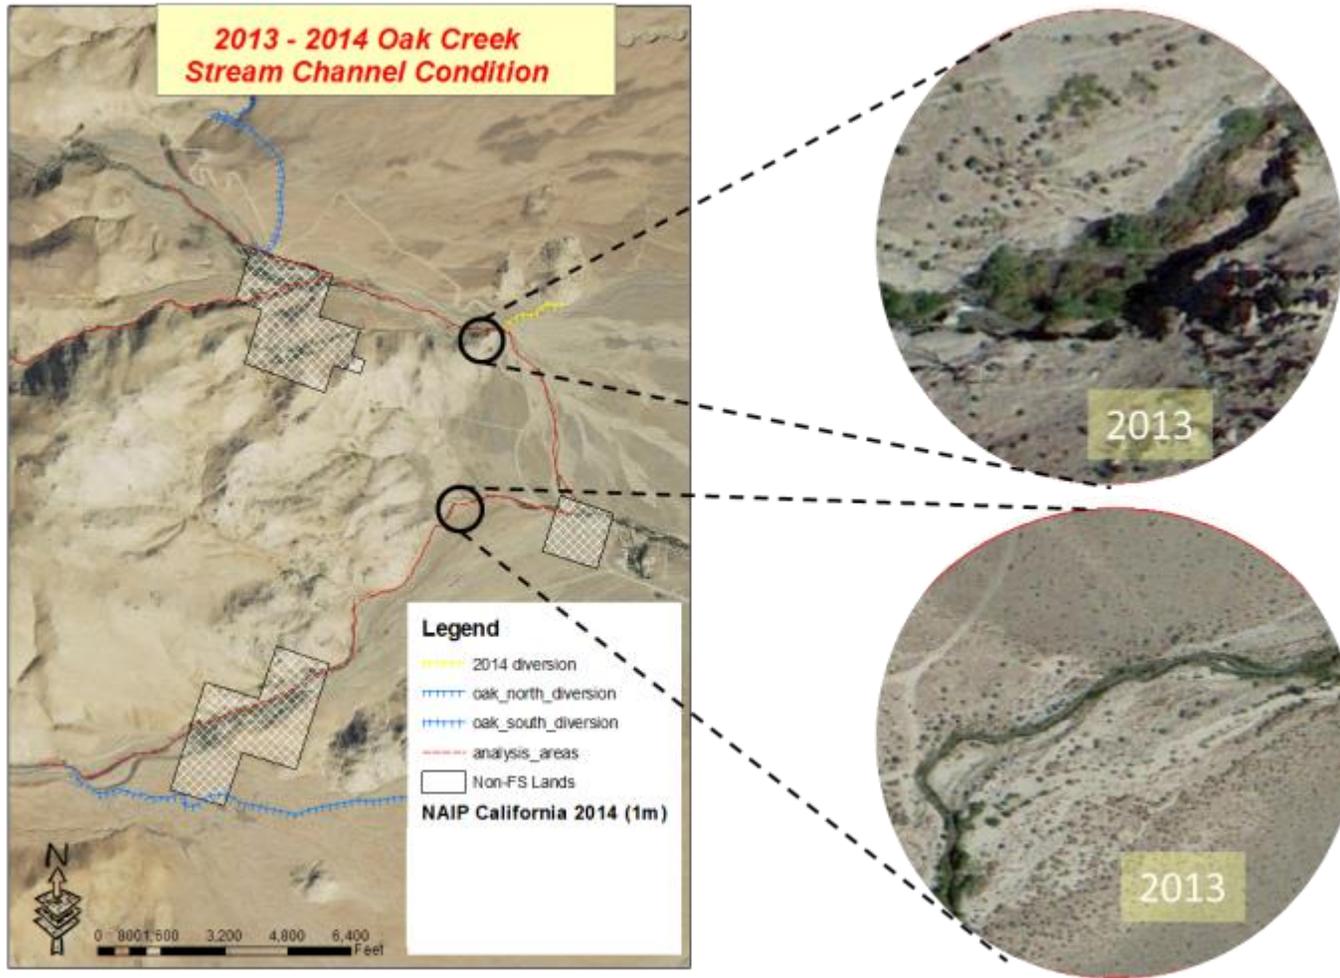
- **Little or no head cut advancement (channel incision) on all three forks**
- **An upward trend in riparian plant colonization on stream banks**
- **An upward trend in stream bed stability with increasing vegetation in areas with braided flow**

On the south fork, stream bank riparian vegetation has come back quickly along the narrow and steep boulder bed sections. This is likely the result of good riparian seed stock and a mild consistent water supply. There are however, two deposition zones downstream of the Bright Ranch that appear to be recovering at a slower pace.

**FIGURE 4 - Location and images of characteristic channel changes on the north and south fork of Oak Creek. Close up images were downloaded from Google Earth Pro and Georeferenced in ArcMap 10.2.2. Images display the level of riparian colonization and show streambeds beginning to stabilize.**

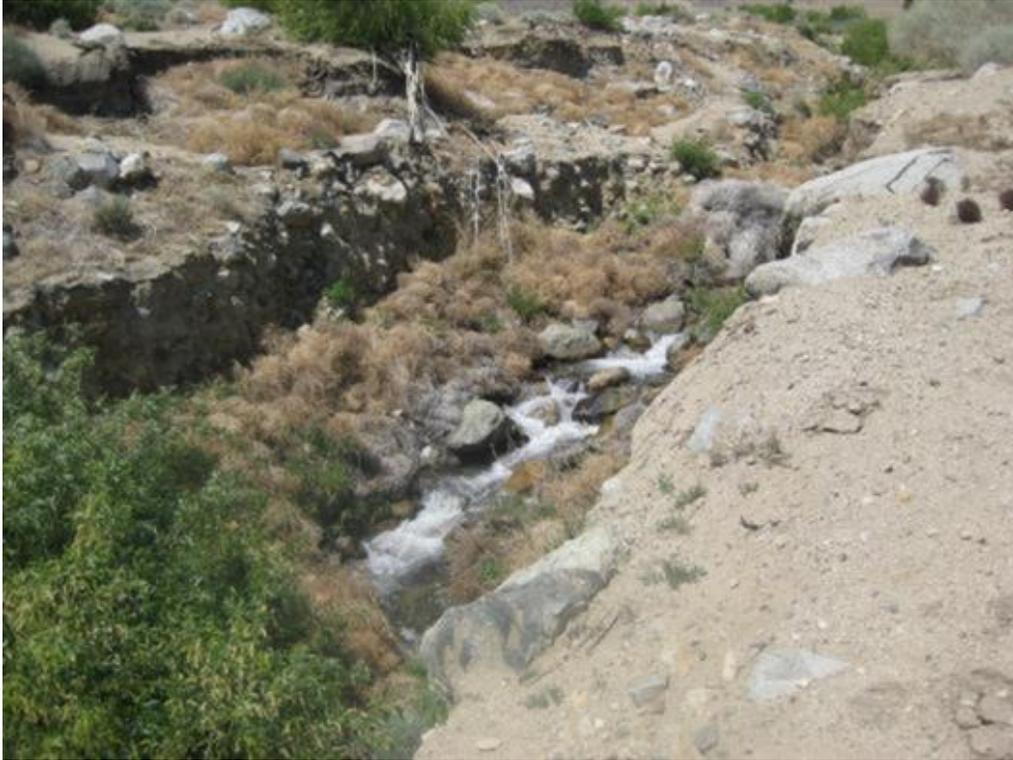
On the north fork, riparian vegetation has comeback in many areas; however there are conditions, specifically weed infestation and gully wall instability, that need to be addressed in order for the north fork to continue the positive trend in stream stability. Sometime before 2010, there was a high wind event that blew Russian thistle off the fan surface and into portions of the north fork (Casey Shannon Inyo National Forest, 2015-Personal Communication). By 2014 many stream bank and bed surfaces were covered with the weed, which inhibits riparian plant colonization. **FIGURE 5** is a photo of a characteristic example of weed infestation on the north fork.

**FIGURE 5 - Russian thistle infestation on the north fork**

The lower and upper north forks have areas where Russian thistle invaded floodplain and channel bank surfaces which is inhibiting riparian plant establishment. This infestation should be treated based on recommendations by the forest botanist.

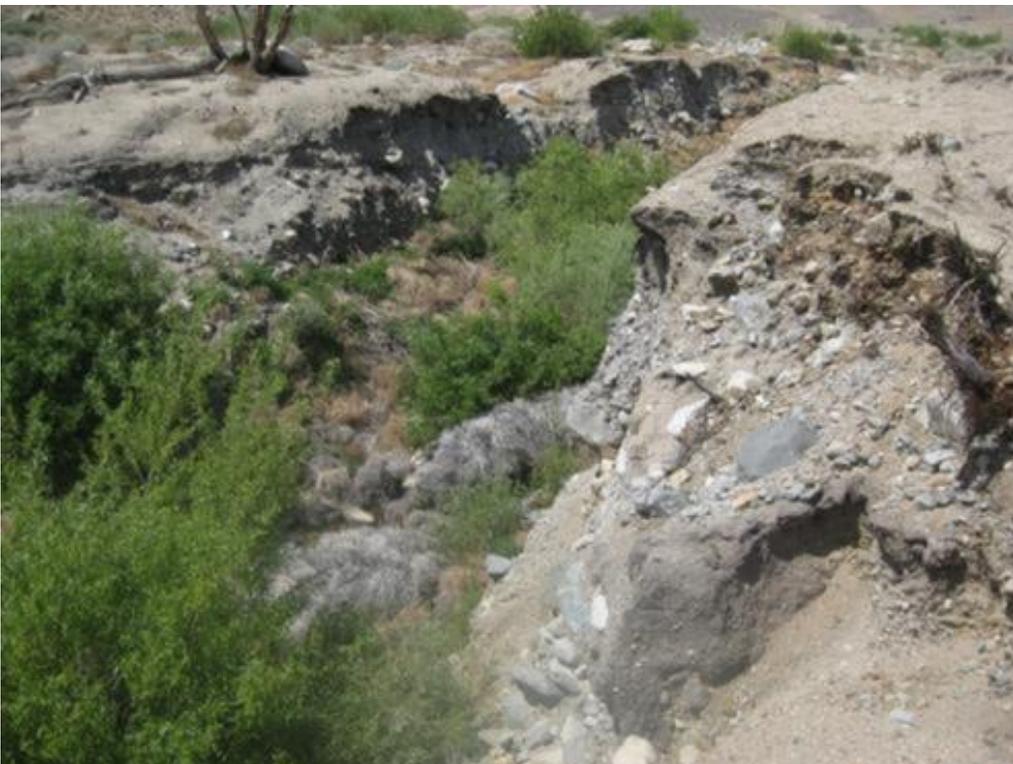
Even though the data on the north fork shows an upward trend in stream channel stability, there are still areas where the channel is deeply incised and the adjacent gully walls are tall, bare, vertical, and unstable presenting a public safety hazard. **FIGURE 6** is a characteristic example of gully wall condition on the north fork upstream of the north fork road crossing.

**FIGURE 6 – Gully wall condition on the north fork**

Material for instream structures should be harvested on site by sloping back (2:1) the gully wall on the north side of upper north fork (to reduce the public safety hazard) and use that as fill material.

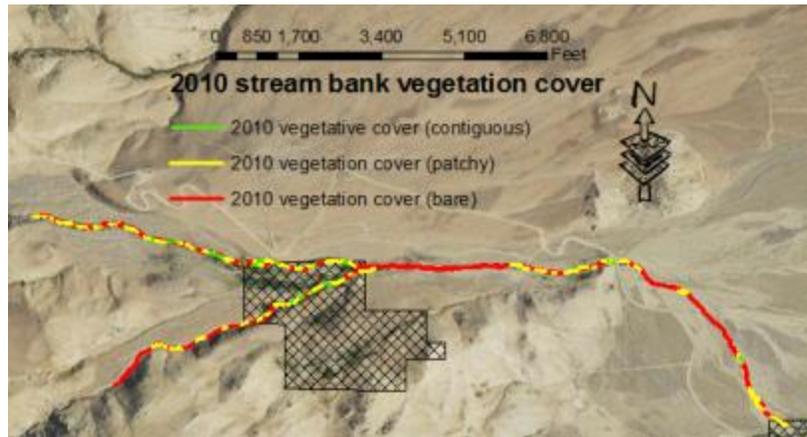
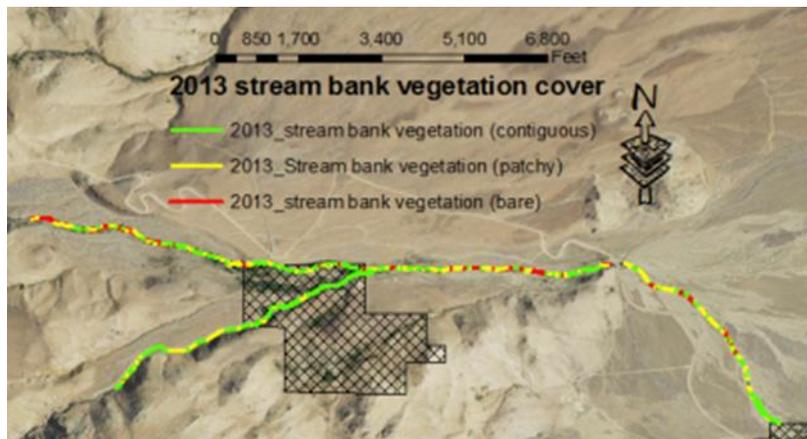
Year	Vegetation cover class		
	% Contiguous (green)	% Patchy (yellow)	% Absent (red)
2010	5	25	70
2013	45	36	19

The percentages show the strong upward trend in contiguous stream bank vegetative cover. It also demonstrates that vegetation is still patchy or bare in some areas and is in need of restorative action in order to maintain the upward trend.

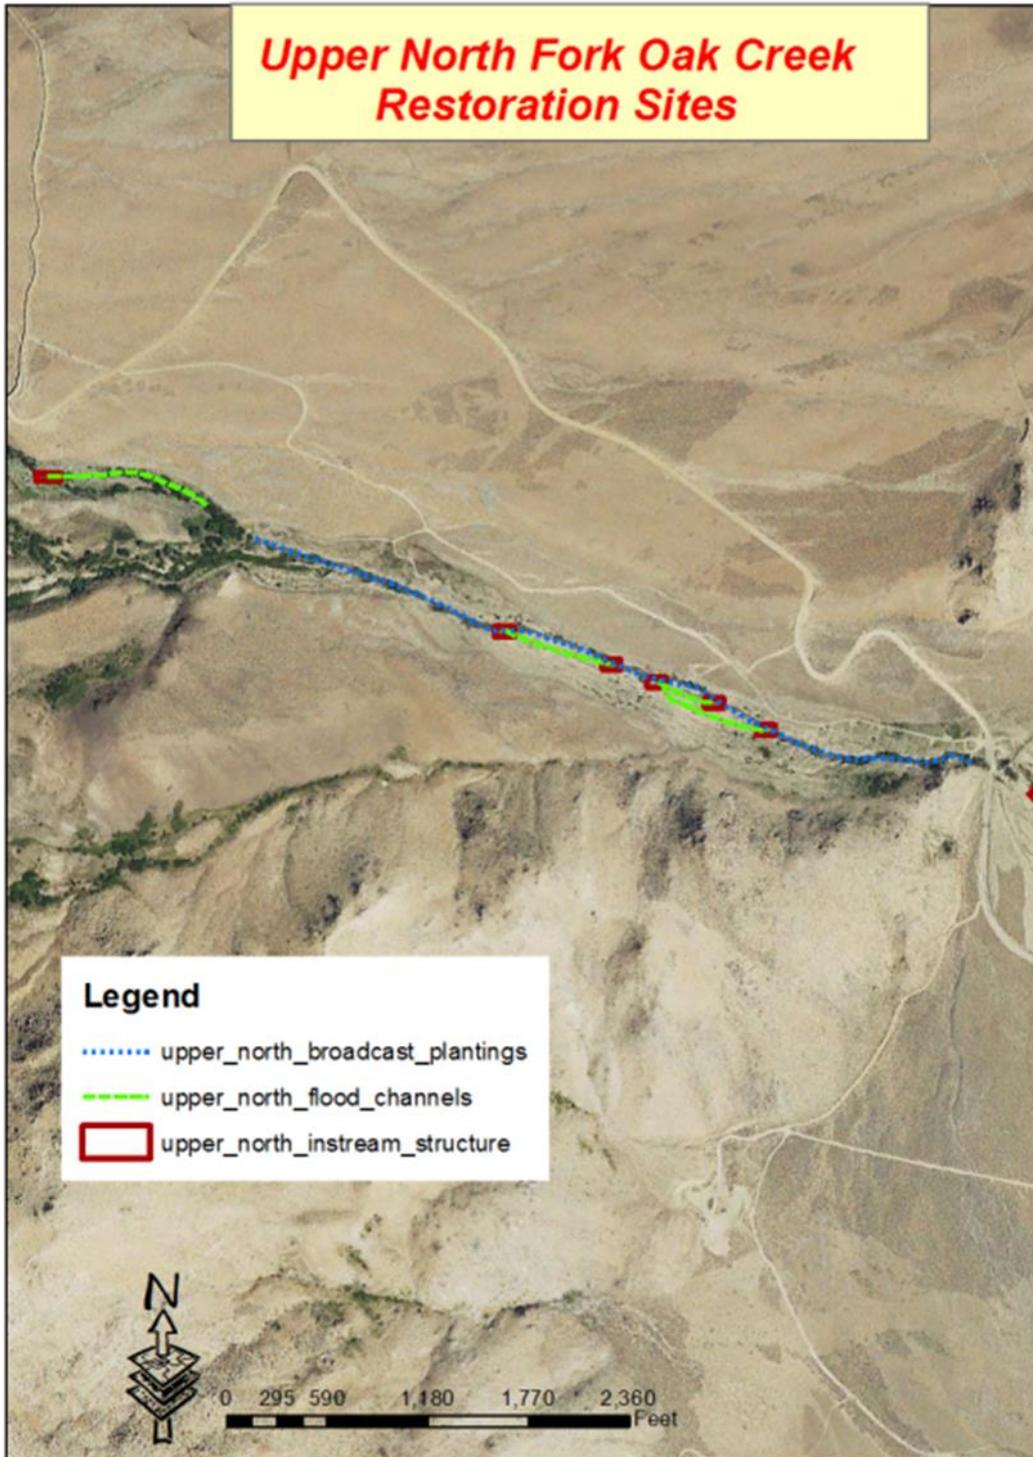
The lower and upper north forks have some distributary channels disconnected by channel incision. A total of Instream/ floodplain structures would raise the stream bed locally to hydrologically reconnect these distributaries. Partner with LADWP to adjust flow regime below diversions to support controlled distributary flow introduction and soil moisture maintenance.

FIGURE 7 – Location of restoration treatments upstream of the north fork road crossing. Weed removal location footprint is within the broadcast riparian planting areas. Gully wall sloping would in areas along the left bank of the creek upstream from the road crossing to the private property boundary

The lower and upper north fork areas still have patches of bare soils next to the channel as well as at the toe of gully wall slopes. Opportunistic planting of willow and cottonwood poles or stakes as well as installation of willow fascines installed perpendicular to the flow line, would further support riparian recovery by adding surface stability and trap sediment trapping potential during higher flows once they are established. Plantings should take place when plant stock and water conditions are appropriate.

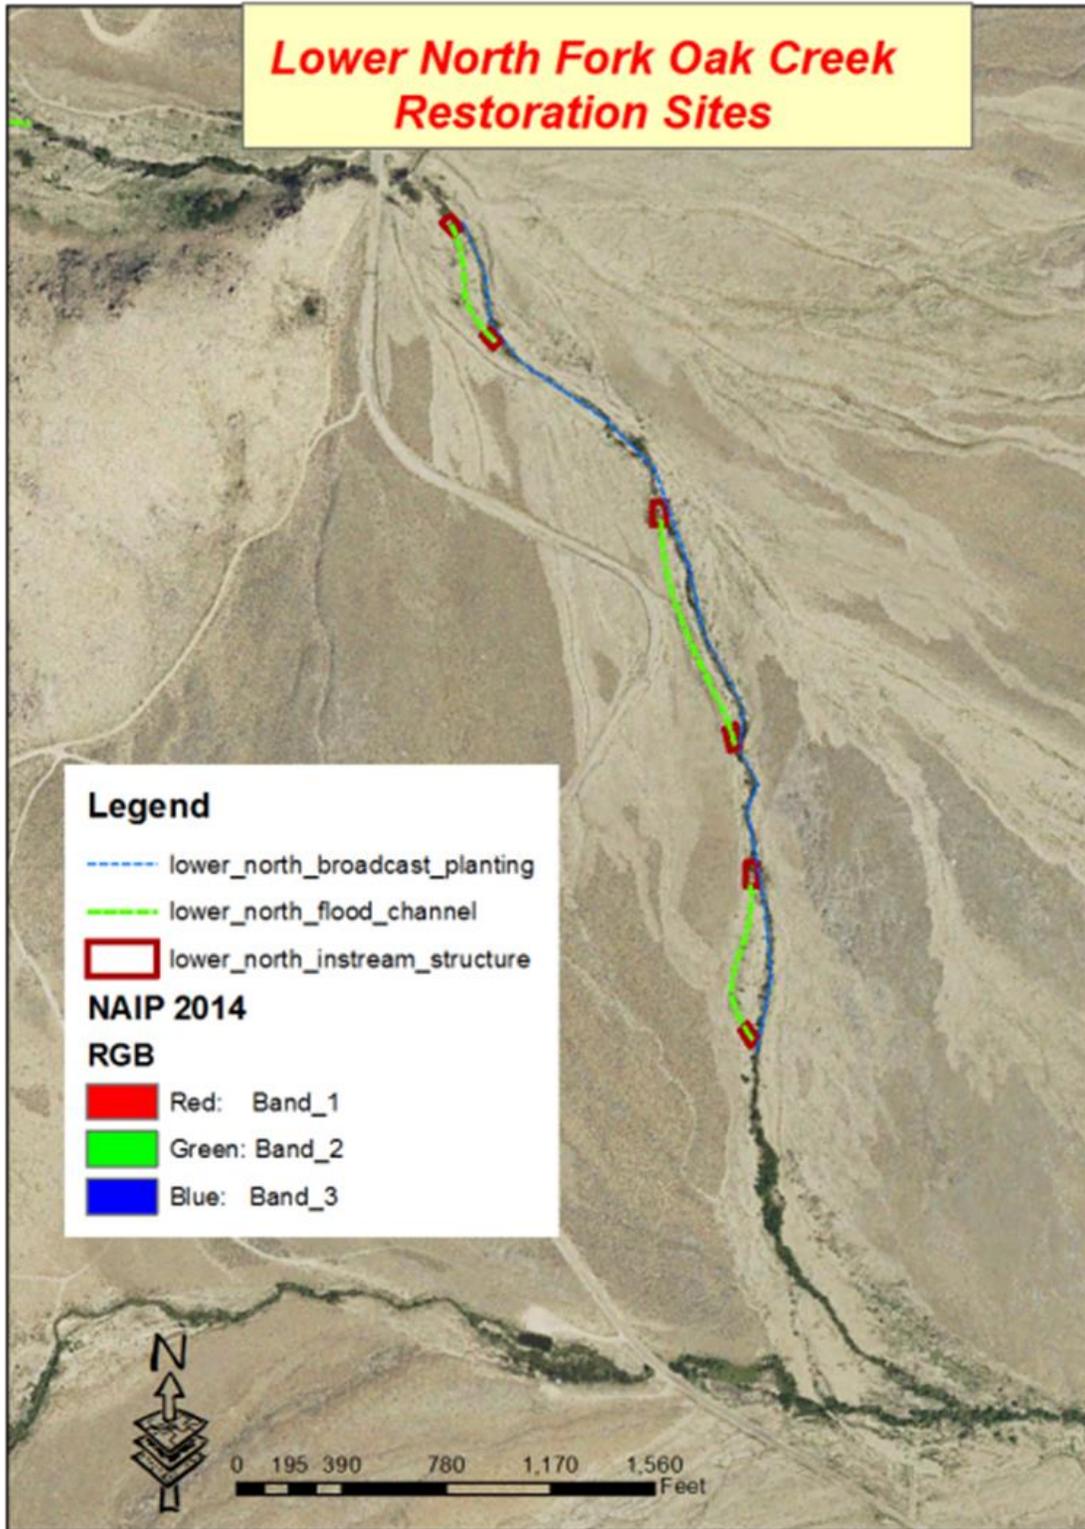
FIGURE 8 – Location of restoration treatments downstream of the north fork road crossing. Weed removal location footprint is within the broadcast riparian planting areas.

Once the structures are established, the old flood channels should be planted with species appropriate for the new hydrologic regime.

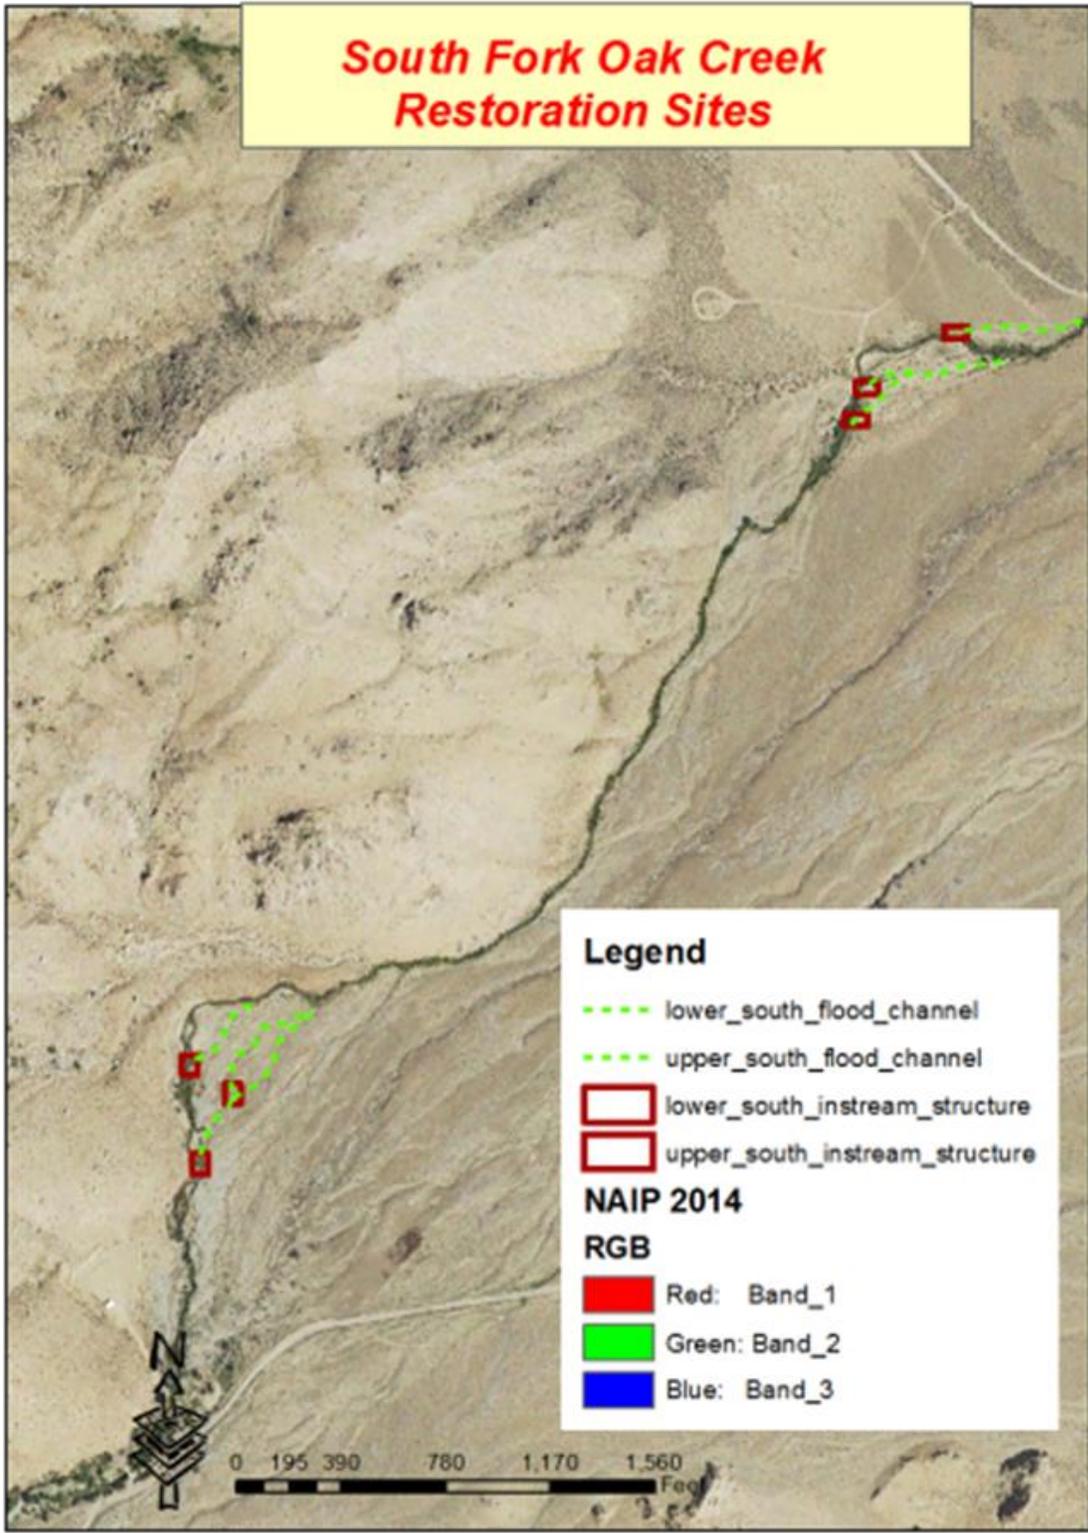
The lower and upper south forks have some flood channels disconnected by minor channel incision. A total of Instream/ floodplain structures would raise the stream bed locally to hydrologically reconnect these flood channels. Partner with LADWP to adjust flow regime below diversions to support controlled distributary flow introduction and soil moisture maintenance.

FIGURE 9 – Location of restoration treatments on the south fork downstream of the Bright ranch.

Once the structures are established, the old flood channels should be planted with species appropriate for the new hydrologic regime.
