Geophysical Assessment of the West Walker River through Antelope Valley

Prepared For

February 20, 2015

Prepared By

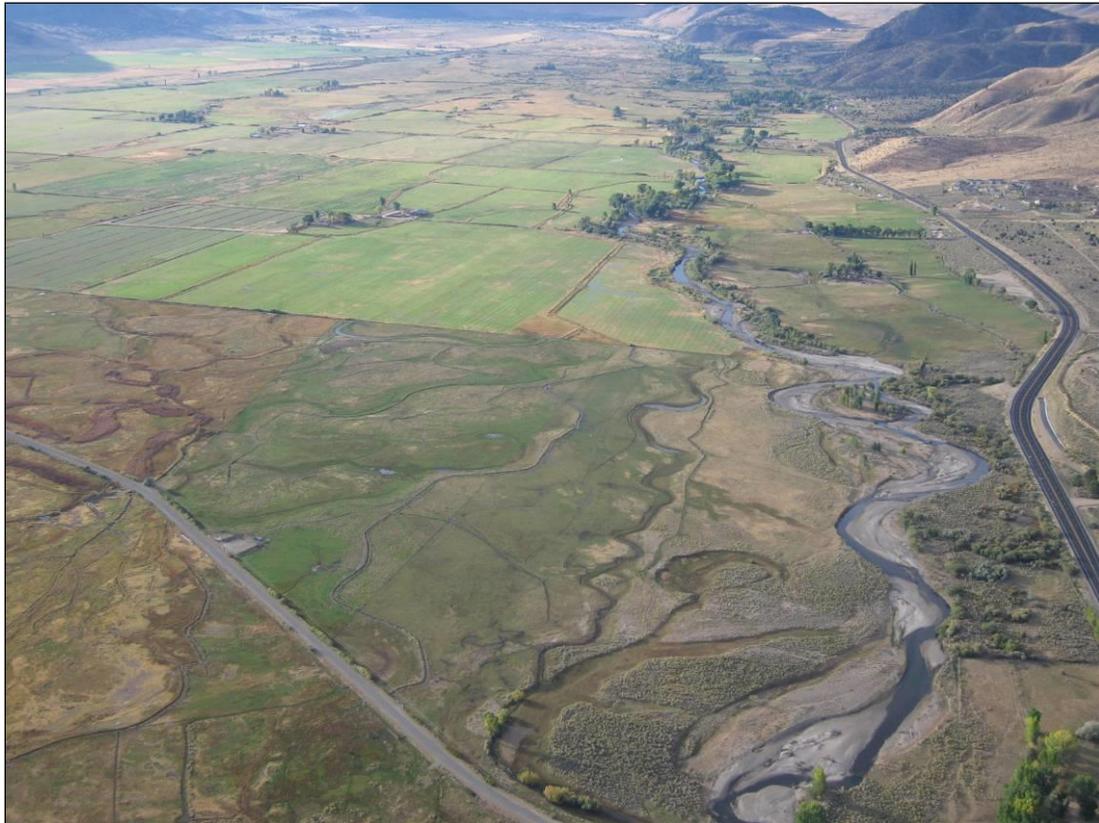
Figure 1-2. Low elevation oblique aerial photo of the extensive agricultural fields along the West Walker River in Antelope Valley in 2006. This southwest view from Topaz Lane is looking upstream.

Agriculture has been the main source of human water use in the Walker River Basin for well over 100 years. Settlement and development of the basin began in the mid-1800s, with the first extensive development of irrigation systems occurring around 1860. Irrigation of Antelope Valley began in 1862 (Horton, 1996), and much of the agriculture continues today (Figure 1-2).

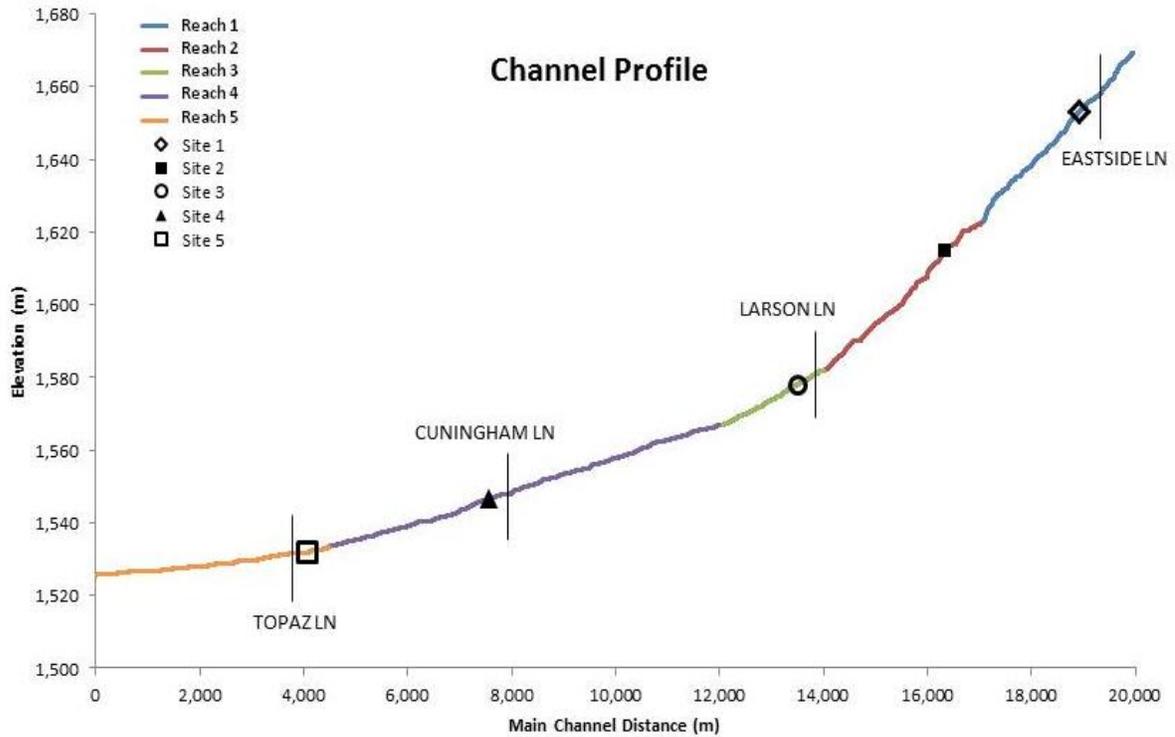
Figure 2-1. Channel profile demonstrating the change in bedslope in relation to channel reaches and study sites.

Figure 2-1 demonstrates the change in bedslope throughout the study area, Table 2-1 summarizes the geomorphic characteristics of each reach, and Figure 2-2 shows the location of the study sites and channel reaches relative to the entire study area.

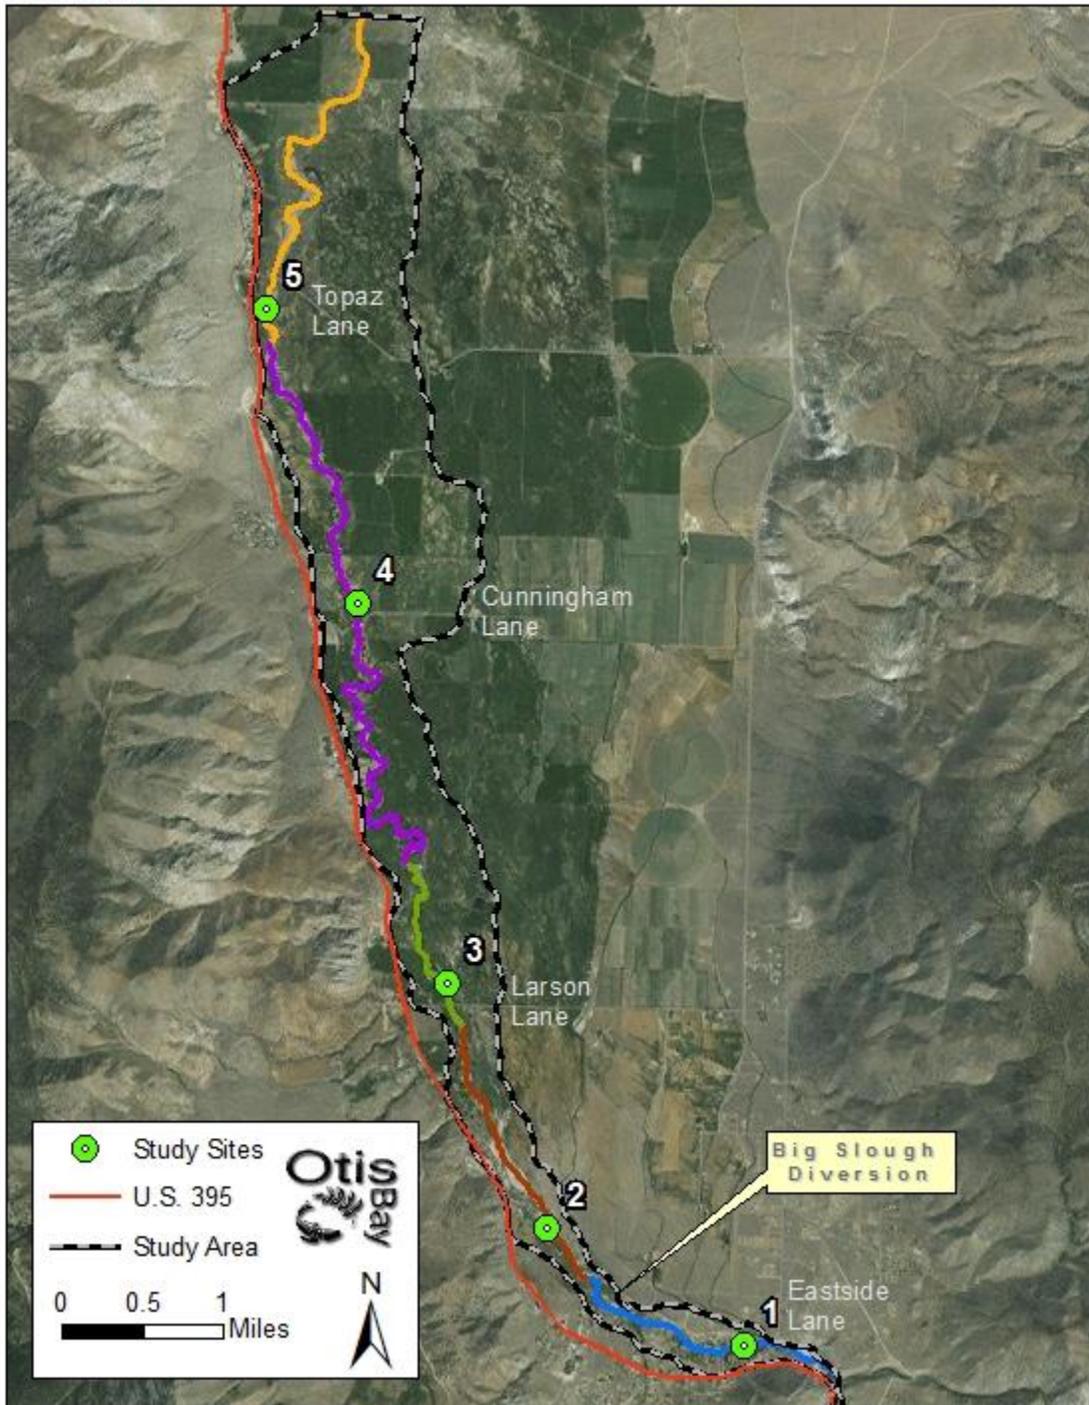
Figure 2-2. Site locations, channel reaches, local roads, and the primary diversion within the overall study area.

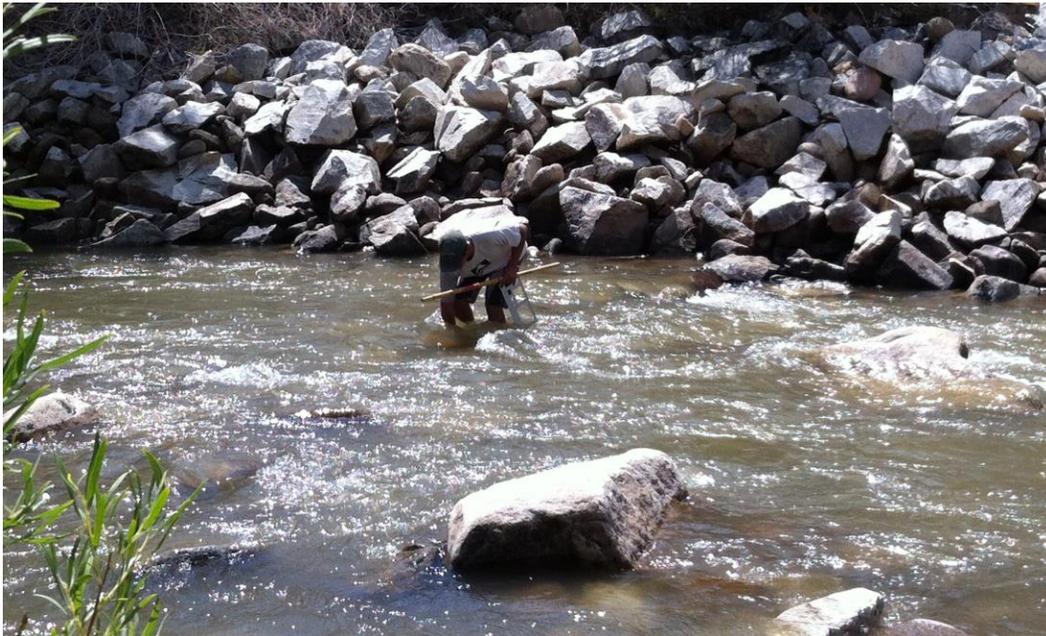
Figure 2-3. Otis Bay employee conducting a pebble count at Site 1.

Pebble counts were conducted at the five study sites using the Wolman Method (Wolman, 1954). The Wolman Method is a widely-used, robust method of streambed characterization, consisting of random sampling of at least 100 points within a particular reach, followed by a statistical analysis of the data. The analysis ultimately results in grain size distribution curves that are useful in developing a preliminary understanding of channel roughness, calculating sediment transport rates, and evaluating distribution of sediment sizes throughout a river system. Otis Bay conducted the pebble counts during low flows in August of 2014 so that wading across the channel would be possible in all areas. From these data, distribution curves were developed for each site and preliminary roughness and sediment transport calculations were performed. The results of this analysis will be discussed further in Section 4.2. Figure 2-3 shows an Otis Bay employee conducting a pebble count at Site 1.

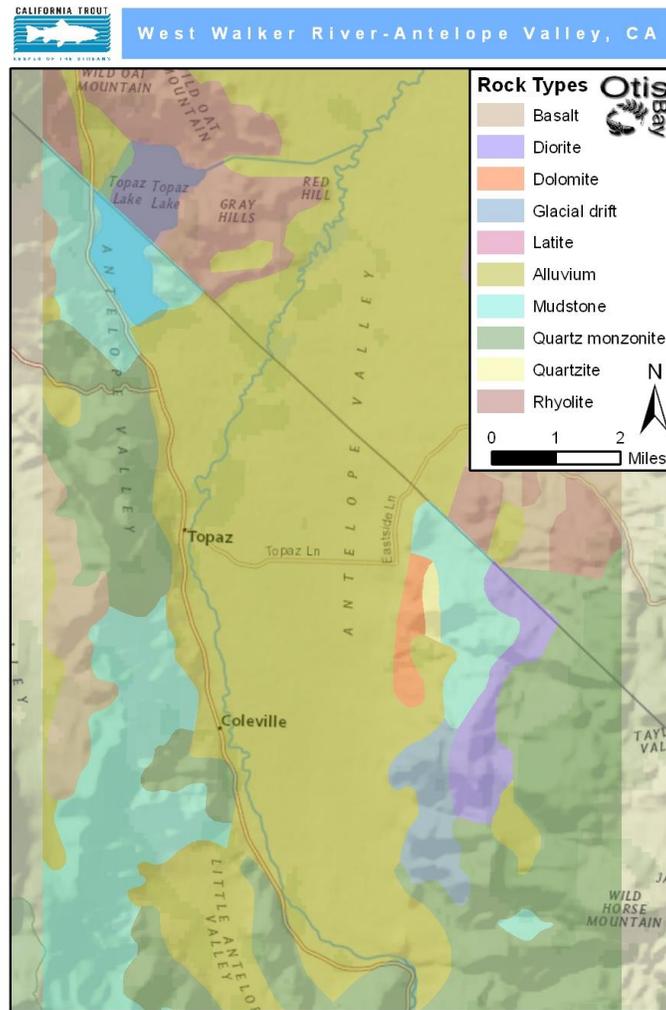
Figure 3-1. Rock types and their distribution in Antelope Valley. This map was produced by merging two maps produced separately for California and for Nevada. In some cases, mapping along the state border has resulted in abrupt changes in the interpretation of rock type. This abrupt change is not a physical reality, but simply a product of different interpretations.

is a depositional area. Much of the sediment generated upstream on the West Walker has accumulated in Antelope Valley along with sediment eroded from adjacent hillslopes. As a result, almost the entire valley floor is characterized as alluvium rock type (Figure 3-1).

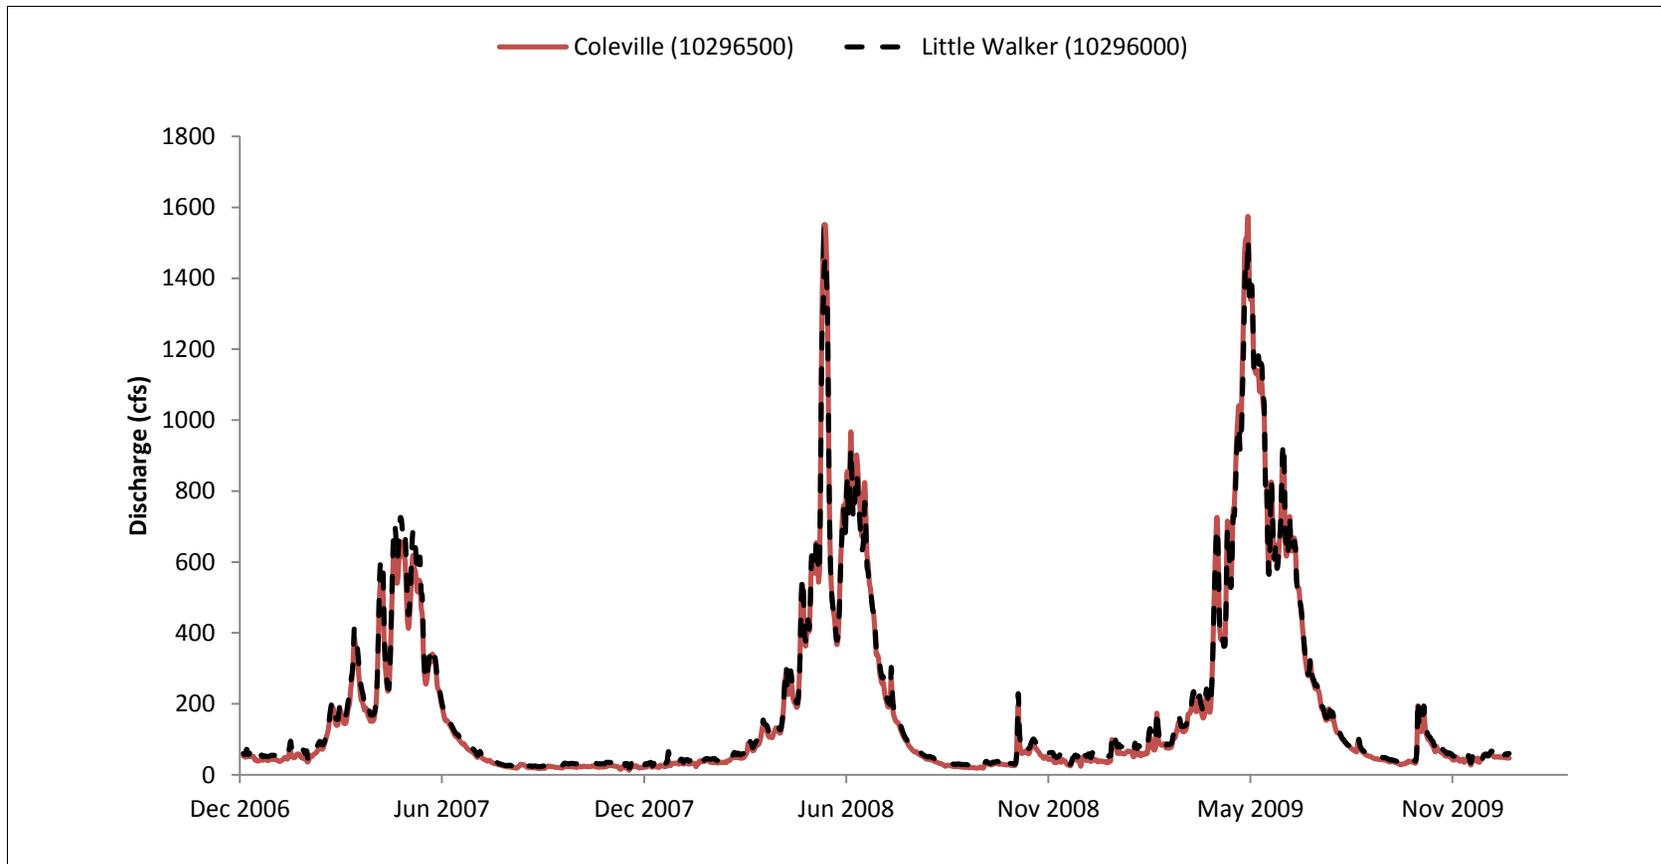
Figure 3-2. Hydrograph comparison of the Little Walker and Coleville gages over a 3-year period (Data obtained from <http://waterdata.usgs.gov/nwis>, accessed August 2014).

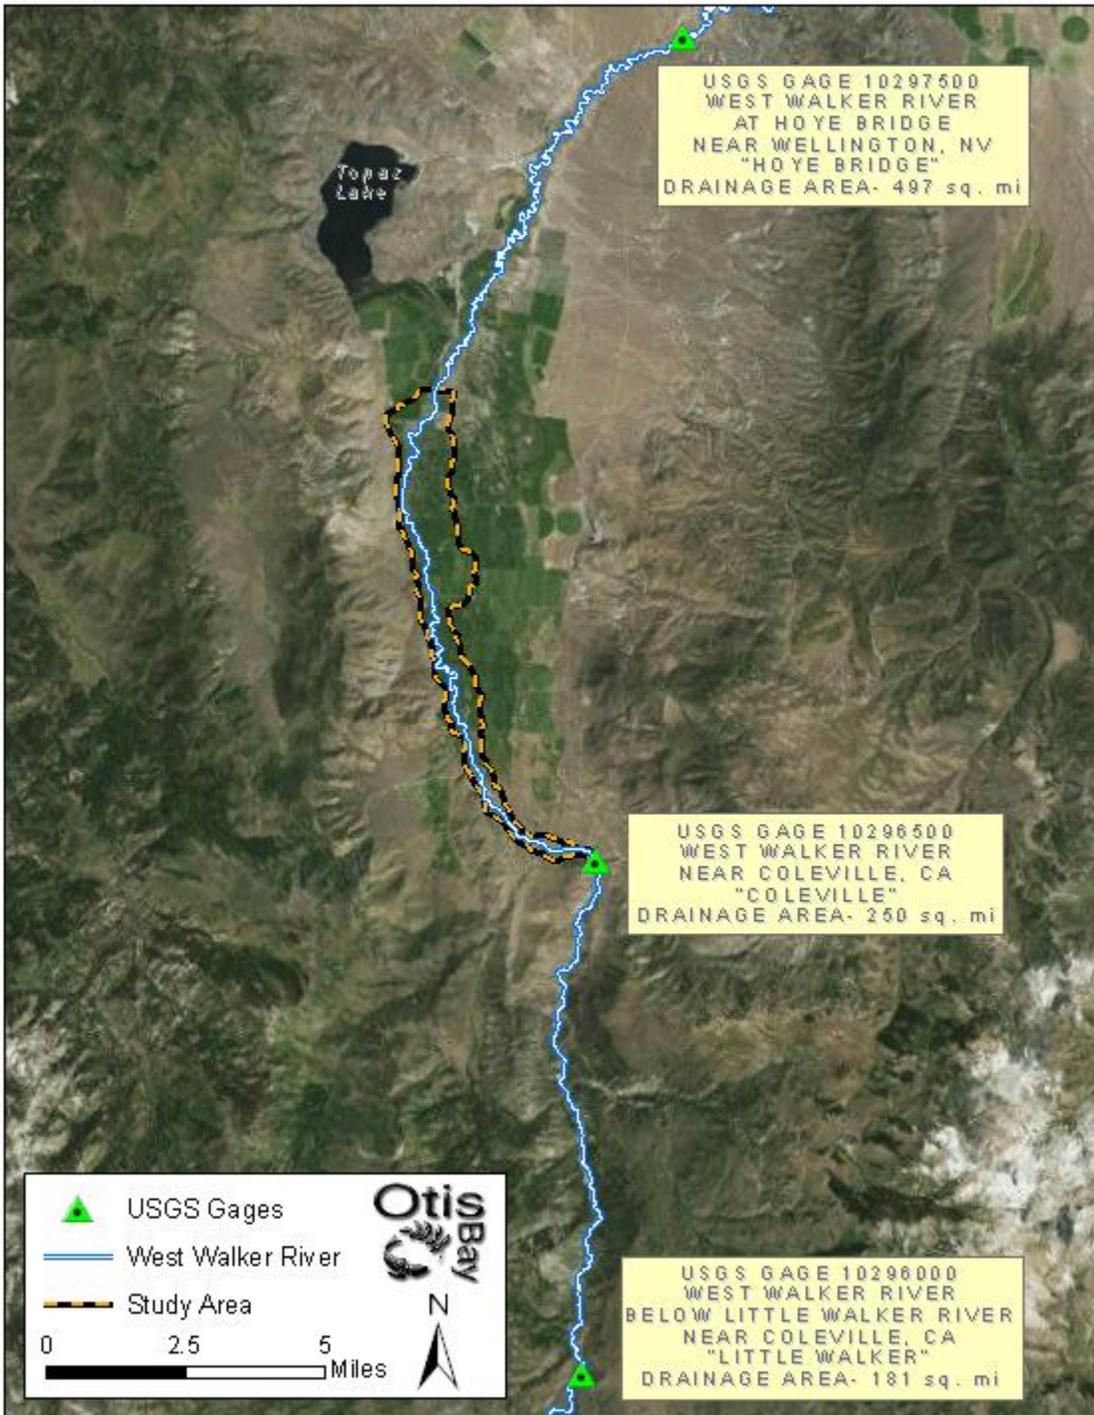
Figure 3-3. Locations and associated information for USGS gages used in this study.

The USGS currently maintains two streamflow gages along the West Walker River upstream of the Topaz Diversion. One gage is located at the upstream end of West Walker Canyon below the confluence with the Little Walker River (Little Walker - 10296000), and the other is located at the mouth of West Walker Canyon, upstream of the town of Walker (Coleville - 10296500). These gages record stage height and discharge, and they have operated for 76 and 112 years, respectively. Data from these gages are almost identical, where slight differences in peak discharges are likely due to individual storm system characteristics and contributions from small drainages upstream of and through West Walker Canyon. To highlight the similarity, a comparison of the Little Walker and Coleville gage hydrographs over an arbitrary 3-year (calendar year) period is provided in Figure 3-2. The locations of all the USGS gages used in this study, along with their common names and drainage basin areas, are displayed in Figure 3-3.

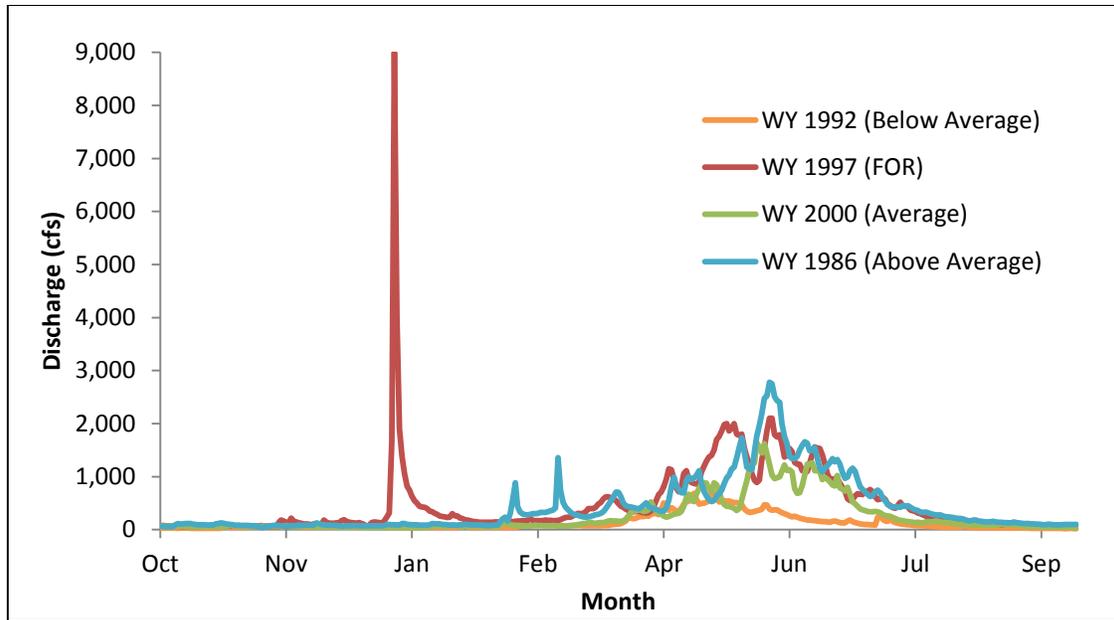
Figure 3-4. Hydrographs at the Coleville gage for average, wet, and dry years, along with the water year (WY) in which the '97 flood occurred (data obtained from USGS).

In comparing hydrologic records over years of varying snowpack and water supply, deviations in the overall volume of water are apparent; however, the general trend remains the same. To illustrate the similarities in trend despite variations in the overall volume of water, the Coleville gage hydrographs for average, wet, and dry water years (WY) are displayed in Figure 3-4. The 1997 water year is also included in this figure, to show the relative timing of a peak discharge occurring outside of the typical spring snowmelt period. Based on existing gage data, the flood of 1997 is the flood of record (FOR).

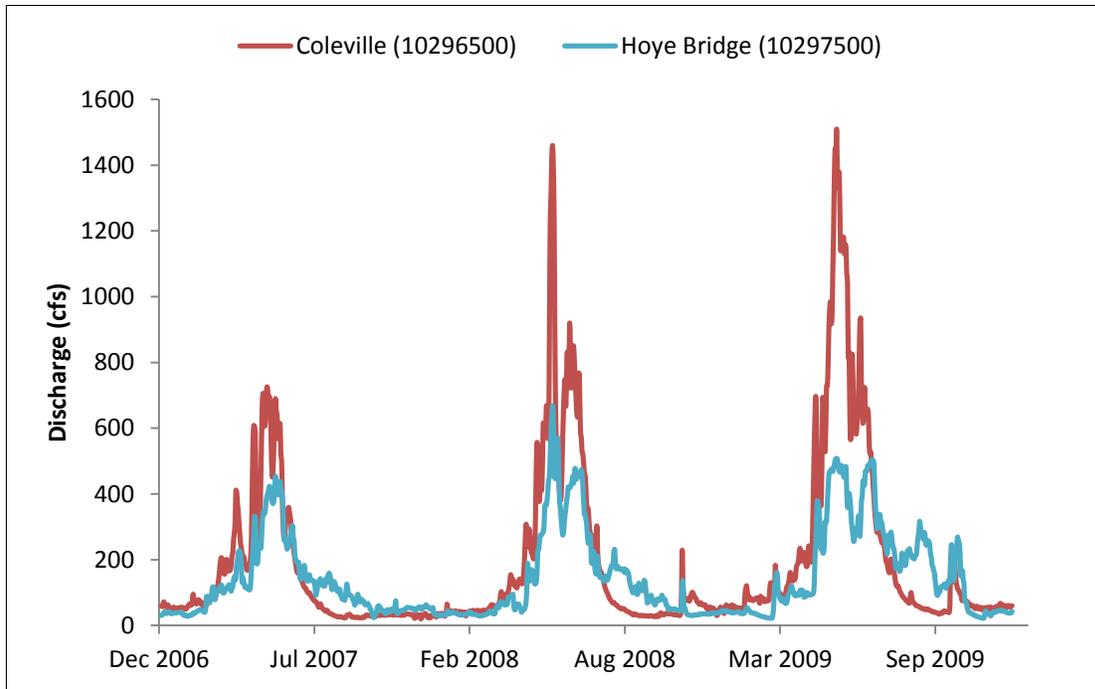
Figure 3-5. Comparison of hydrographs upstream (Coleville) and downstream (Hoye Bridge) of Topaz Reservoir demonstrating the hydrologic effects of the dam (Data obtained from USGS).

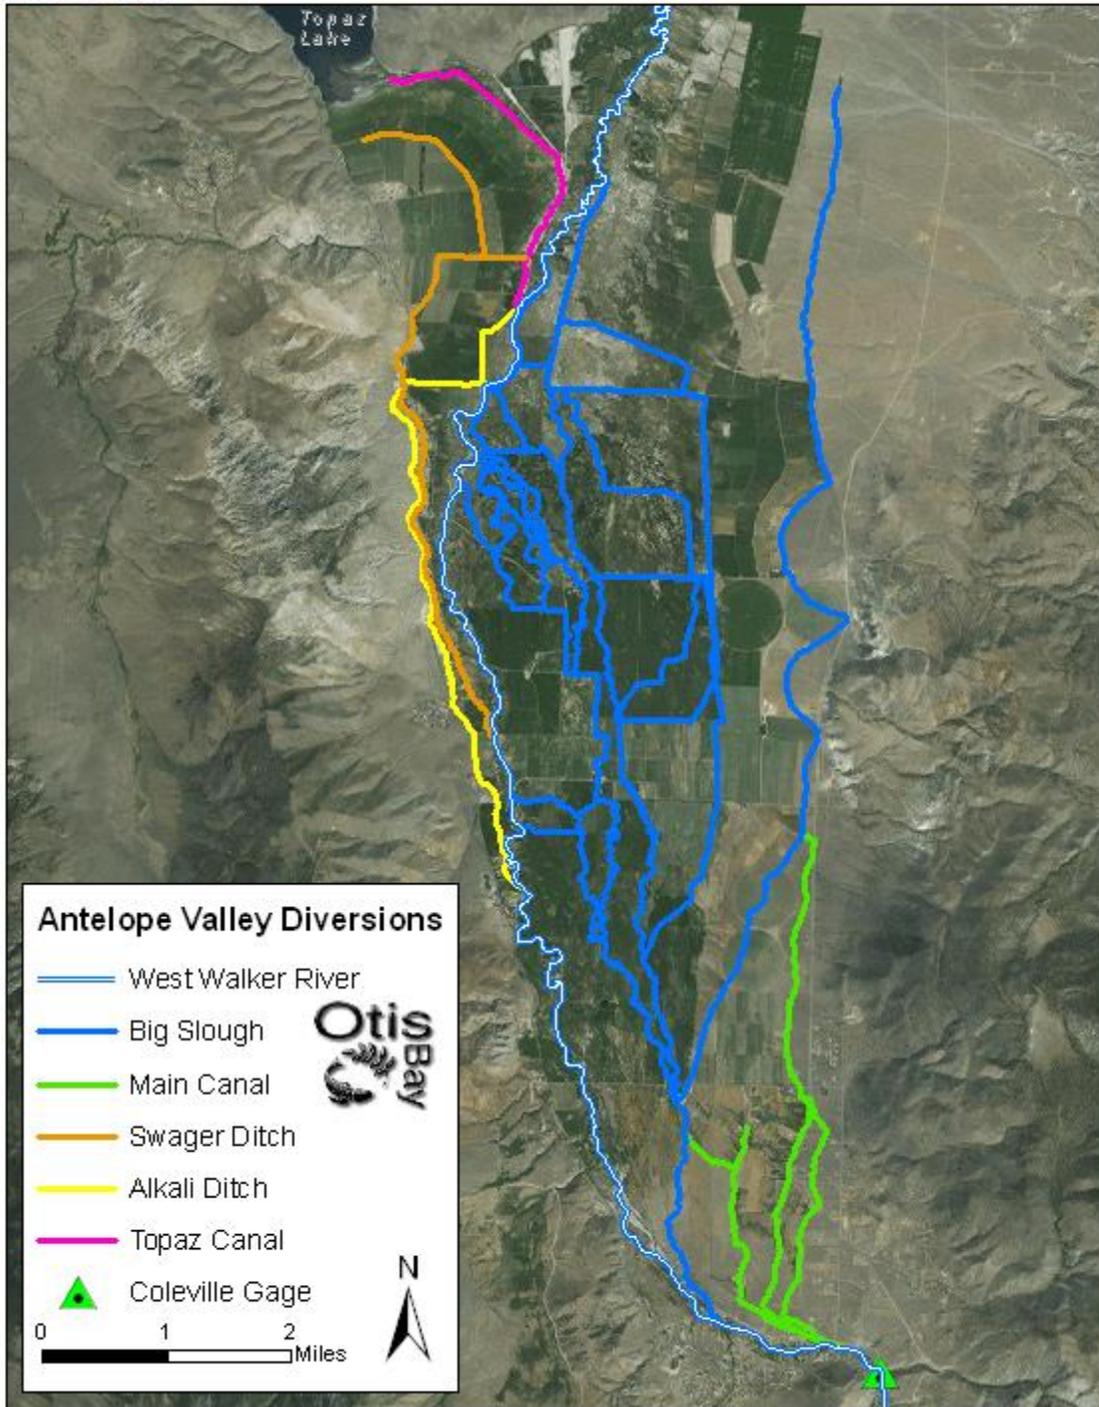
Figure 3-6. The primary diversions through the upstream portion of Antelope Valley. Note: This map does not contain every small supply and return ditch but rather provides a general overview of the main stems of the diversions.

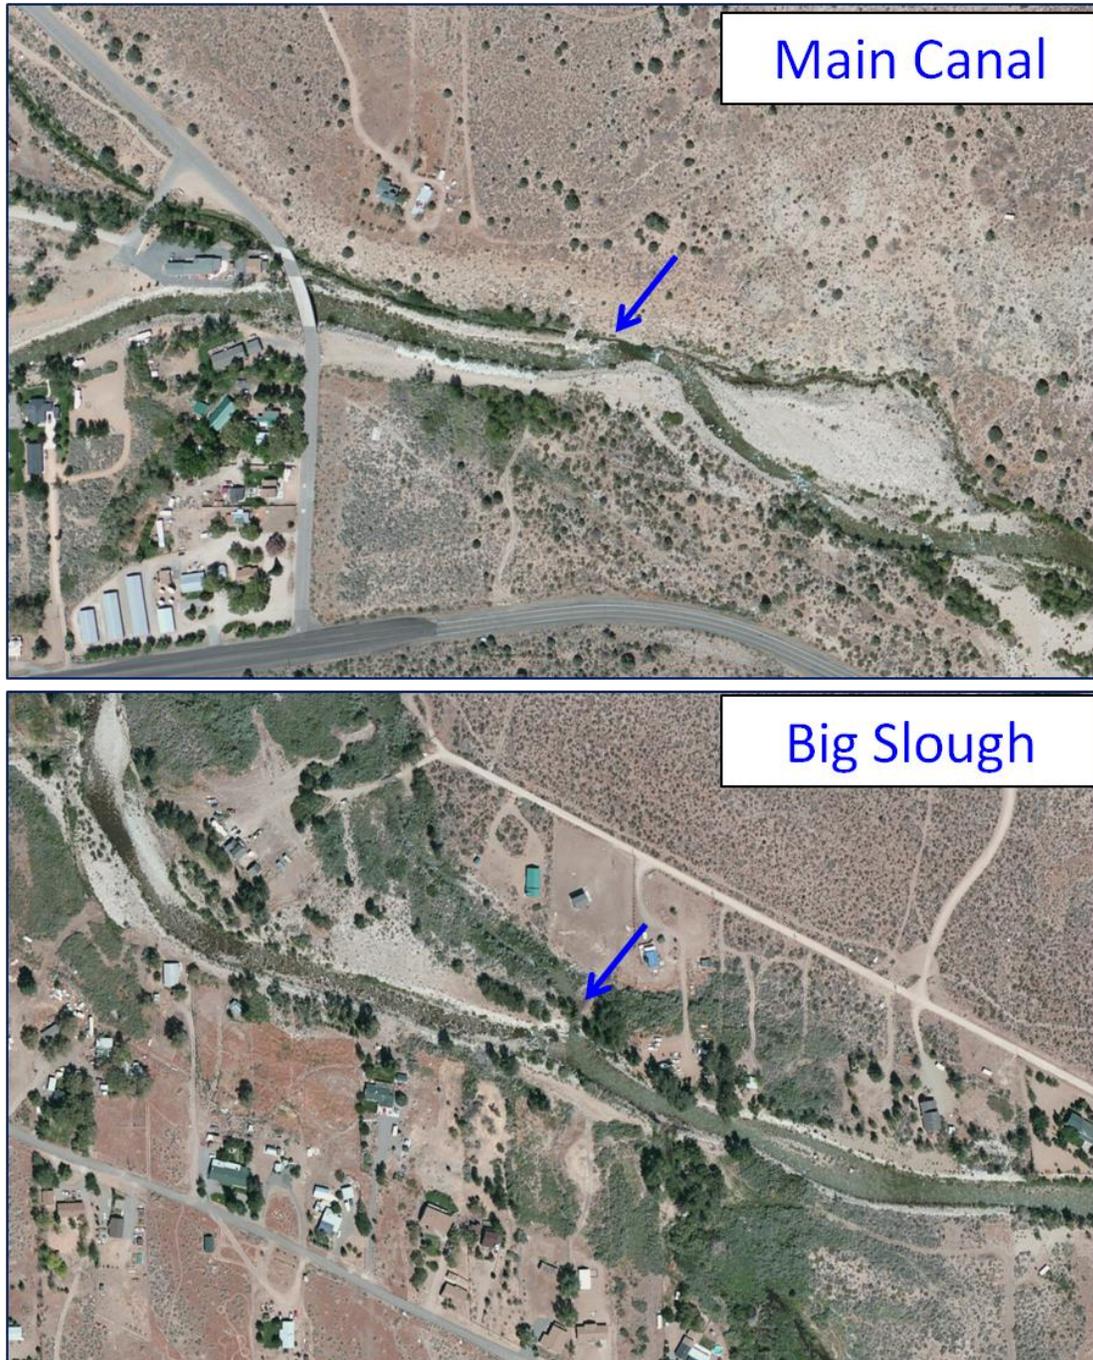
Figure 3-7. Comparison of relative locations of the Main Canal (top) and Big Slough (bottom) diversions on the West Walker River.

Both the Main Canal and Big Slough diversions are unlined canals with various control structures, smaller sub-division structures and return ditches throughout the network. As the name suggests, the Big Slough diversion primarily follows a naturally formed slough channel through the valley. The inlet for the Big Slough diversion consists of a

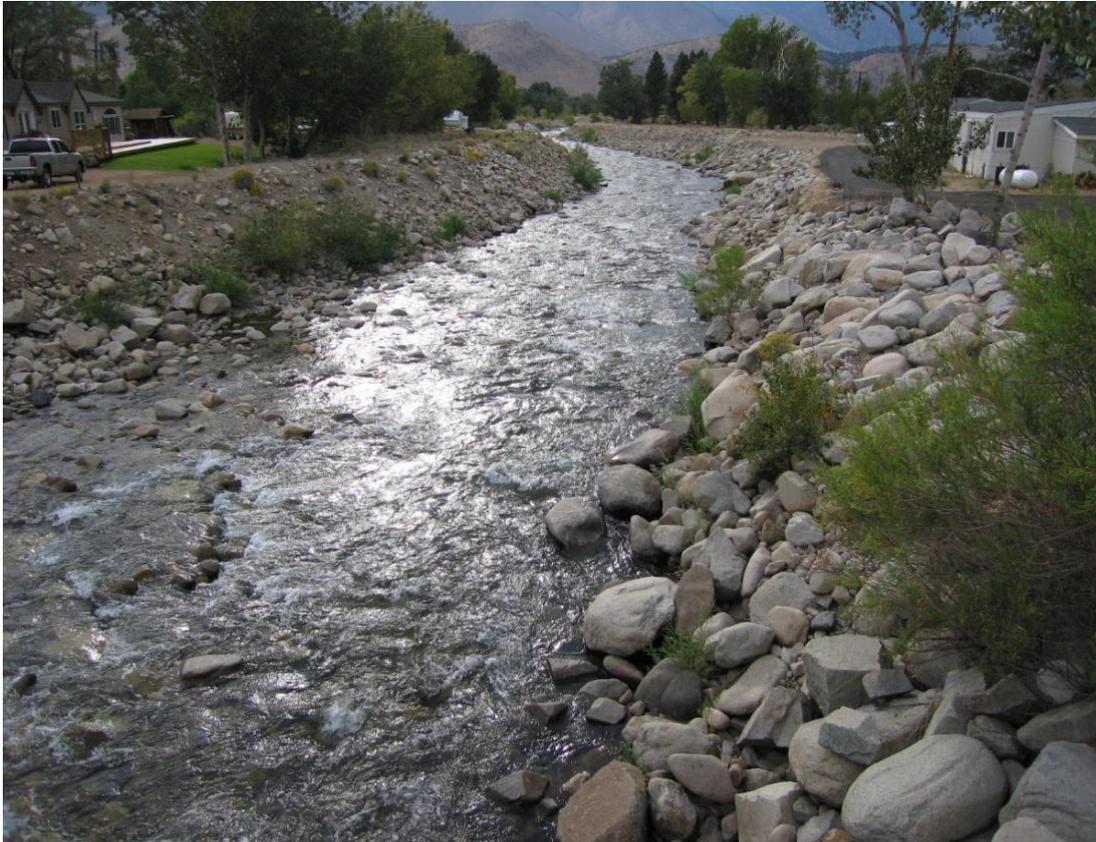
Figure 3-8. Rip-rapped and leveed river banks protect Walker homesteads from overbank flows.

Even farther downstream, local residents have stated that portions of the West Walker River, particularly between the town of Walker and Larson Lane, have been leveed or armored in order to contain the river and prevent further channel migration during peak discharges. Residents have further expressed, however, that attempts to confine a dynamic river to a single channel have been largely unsuccessful, as the river typically returns to older, inactive channels during high flow events.

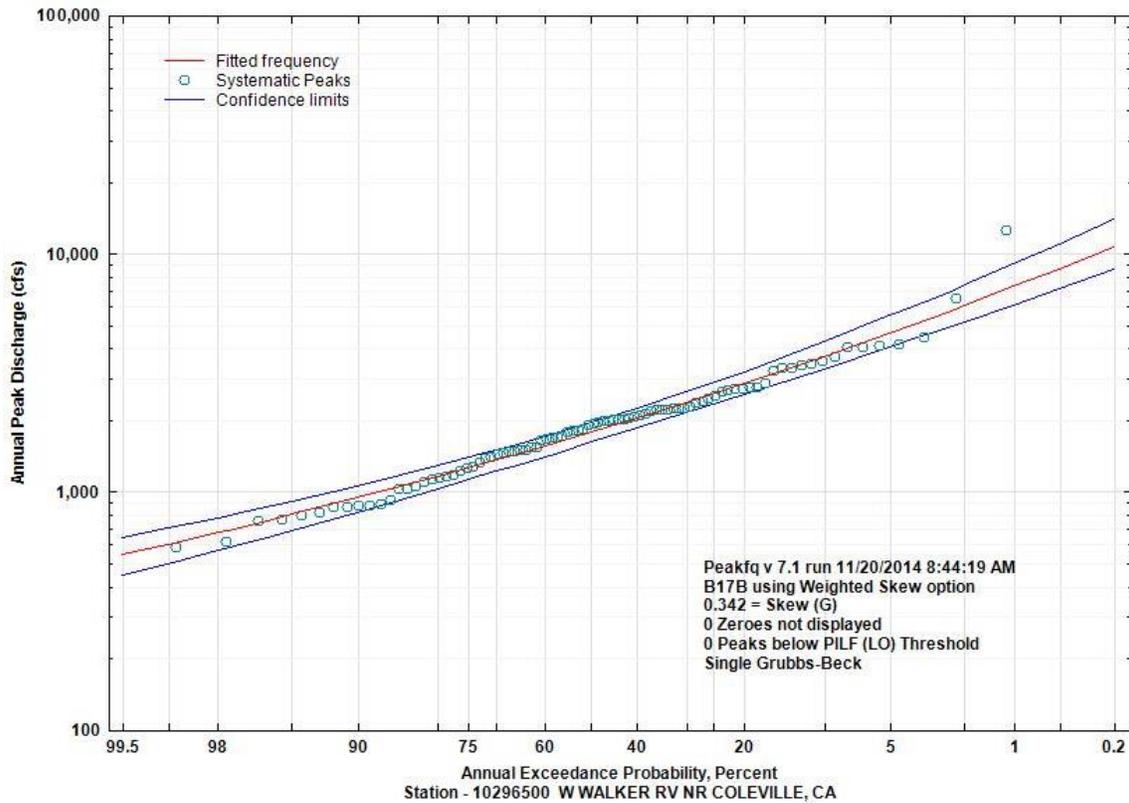
Figure 3-9. Flood frequency plot for the Coleville gage generated using the USGS PeakFQ program.

A flood frequency analysis was conducted on data from the Coleville gage using the USGS PeakFQ program, which utilizes the WRC bulletin 17-B procedure (available online at <http://water.usgs.gov/software/PeakFQ>). This statistical procedure is widely used in the field of hydrology and provides sound statistical estimates of expected flood frequencies and magnitudes. Plots of the flood frequencies generated by the PeakFQ software for the Coleville gage are provided in Figure 3-9. The red line represents the fitted frequency data, blue lines represent the upper and lower 95% confidence limits, and points are measured data for peak discharges for each year. Approximate magnitudes of various floods are presented in Table 3-1.

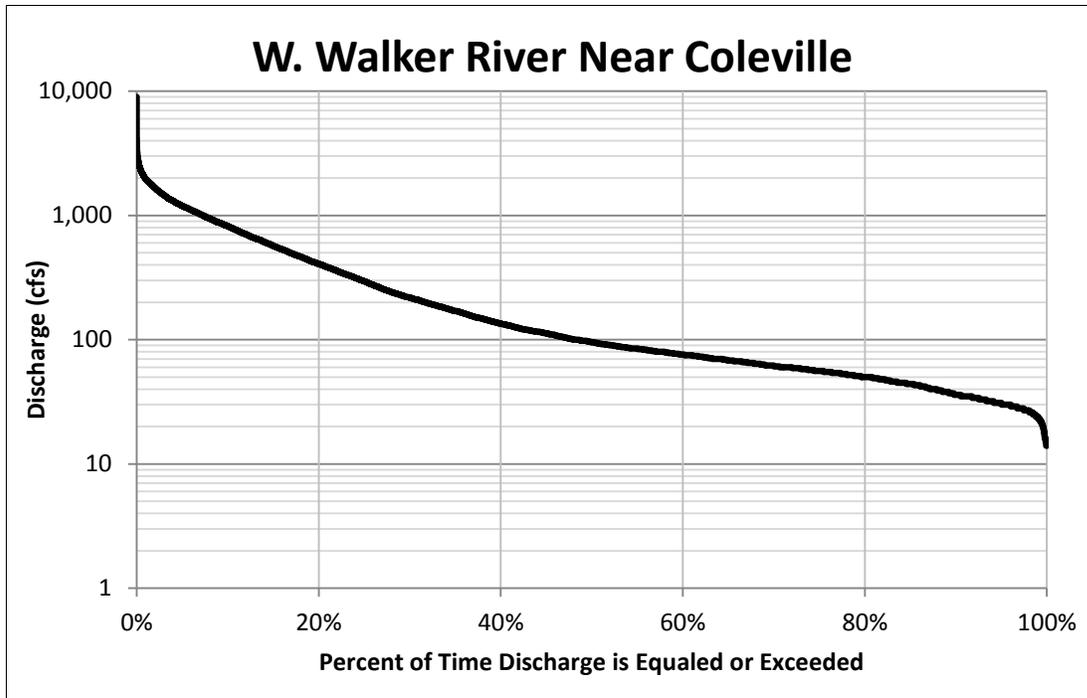
Figure 3-10. Flow duration curve for the Coleville gage (data obtained from USGS).

Flow duration, which is derived from exceedance probability, is another useful hydrologic analysis that provides information about the overall distribution of discharge in a river system. Flow duration curves are developed from historical stream flow data, and represent the percentage of time that a particular discharge is equaled or exceeded within the period of record. Ultimately, flow duration curves can be used to determine the overall expected duration of a given discharge in any year, with reasonable accuracy. Understanding flow duration is crucial for estimating sediment transport quantities, a process which will be discussed further in Section 4.2. A flow duration curve was developed for the Coleville gage, based on complete water years during the period of record, and is displayed in Figure 3-10.

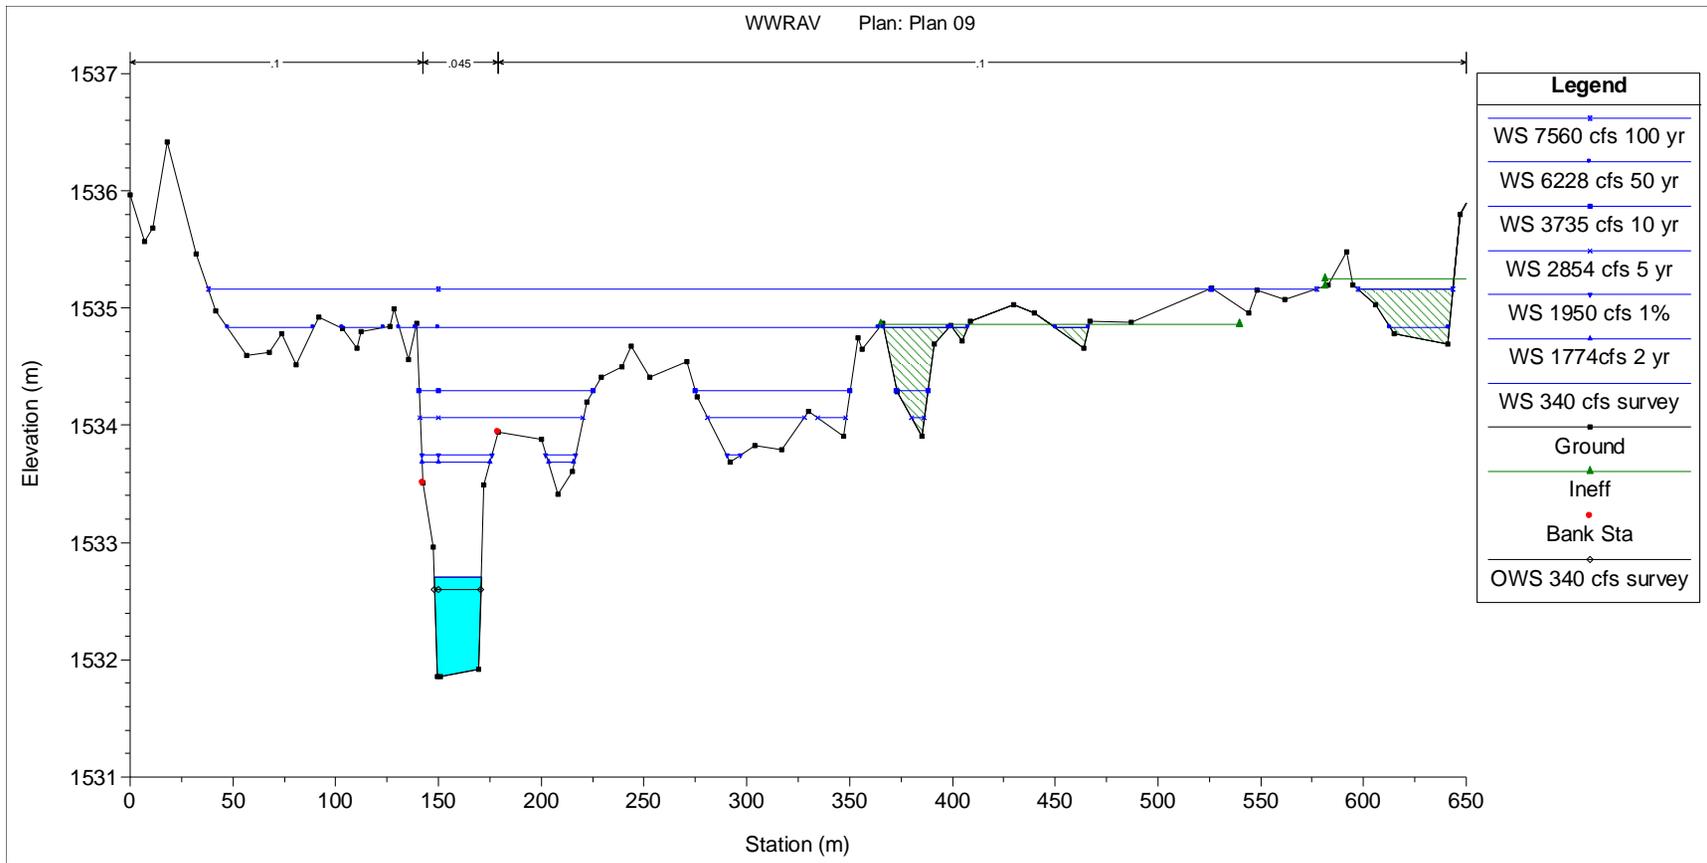
Figure 4-1. HEC-RAS cross section for Site 5. Blue lines represent water surface profiles for various flow rates. Green hatched areas represent ineffective flow areas.

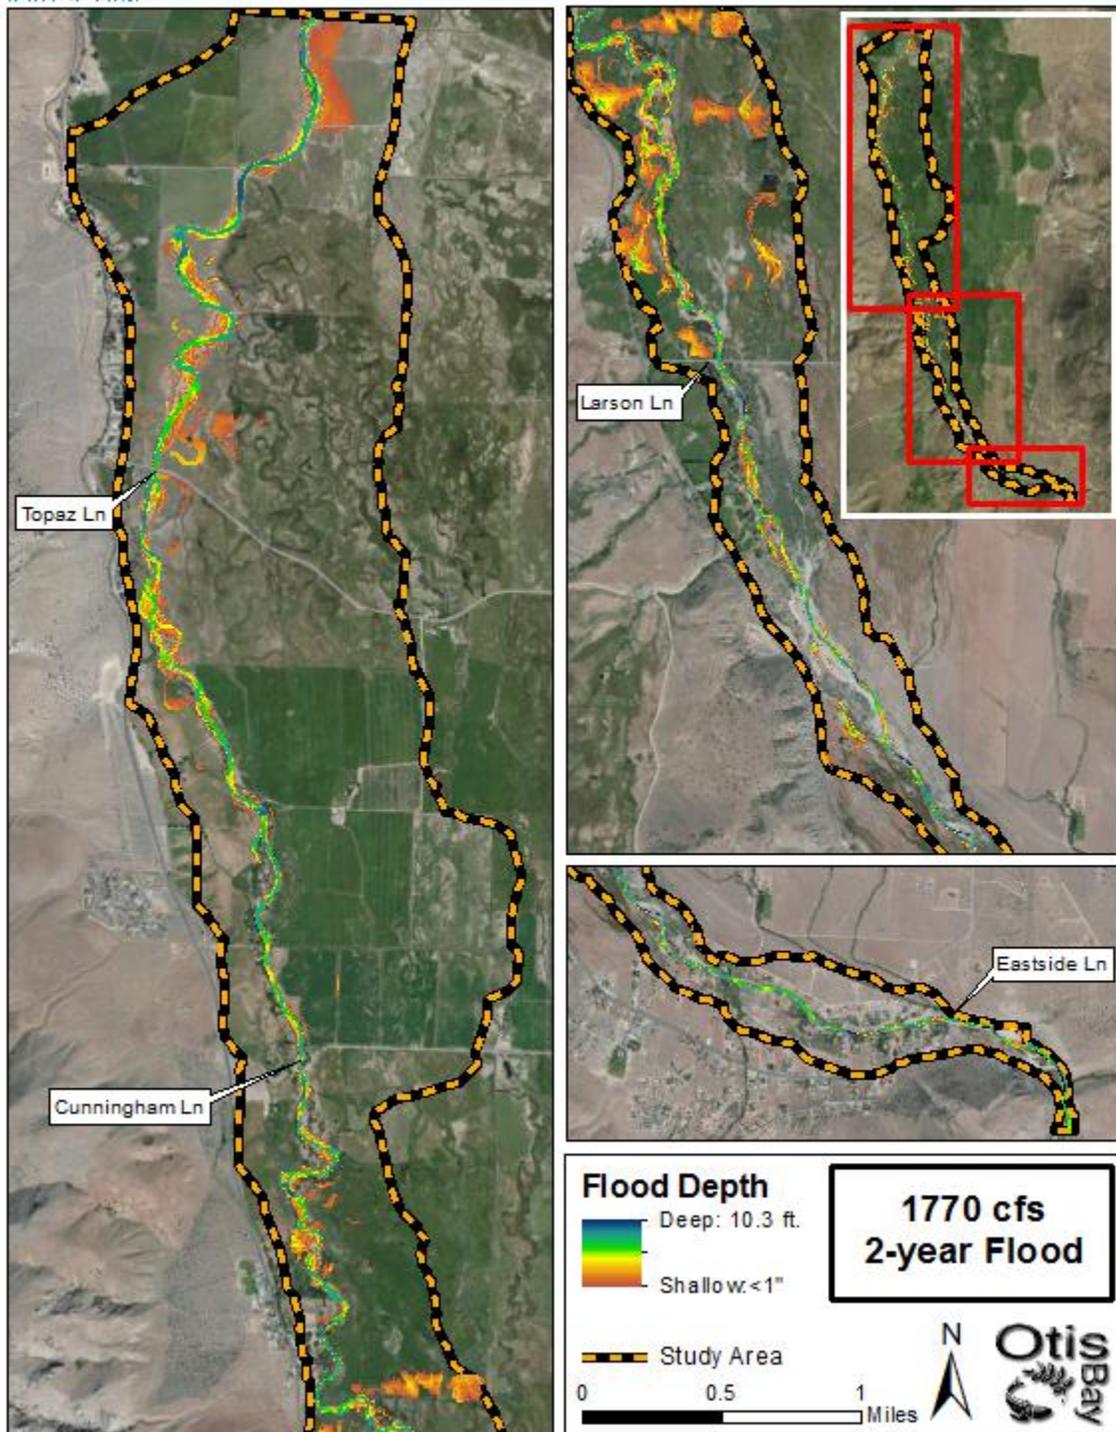
Figure 4-2. Modeled flood depths for a 2-year flood event (1,770 cfs) showing mostly bankfull flow with some areas of overbank flow.

The analysis suggests that minimal overbank flow occurs through the town of Walker, except for small areas during extreme events, which is consistent with expectations, as the channel was constructed during emergency repairs in 1997 with the capacity to contain large floods. Downstream of the town of Walker and the Big Slough diversion, widespread floodplain inundation is observed during higher flow events (i.e., >10-year floods). Although the floodplain remains relatively narrow upstream of Larson Lane, downstream of Larson Lane the channel is well connected to the floodplain, where fewer channel modifications have been made aside from the built-up levees near the Larson Lane Bridge. Inactive channels become activated, and the inundation is widespread. The reach between Cunningham and Topaz Lanes consists of agricultural fields on the east side of the river, resulting in a substantially altered floodplain, with most of the overbank flow being confined to a narrow area directly adjacent to the river channel during moderate flows up to a 10-year flood event. Overbank flow becomes widespread again downstream of Topaz Lane, even in areas with agricultural fields. During a 100-year event, overbank flow is widespread throughout the valley, regardless of channel configurations in various reaches, as is expected for extreme events.

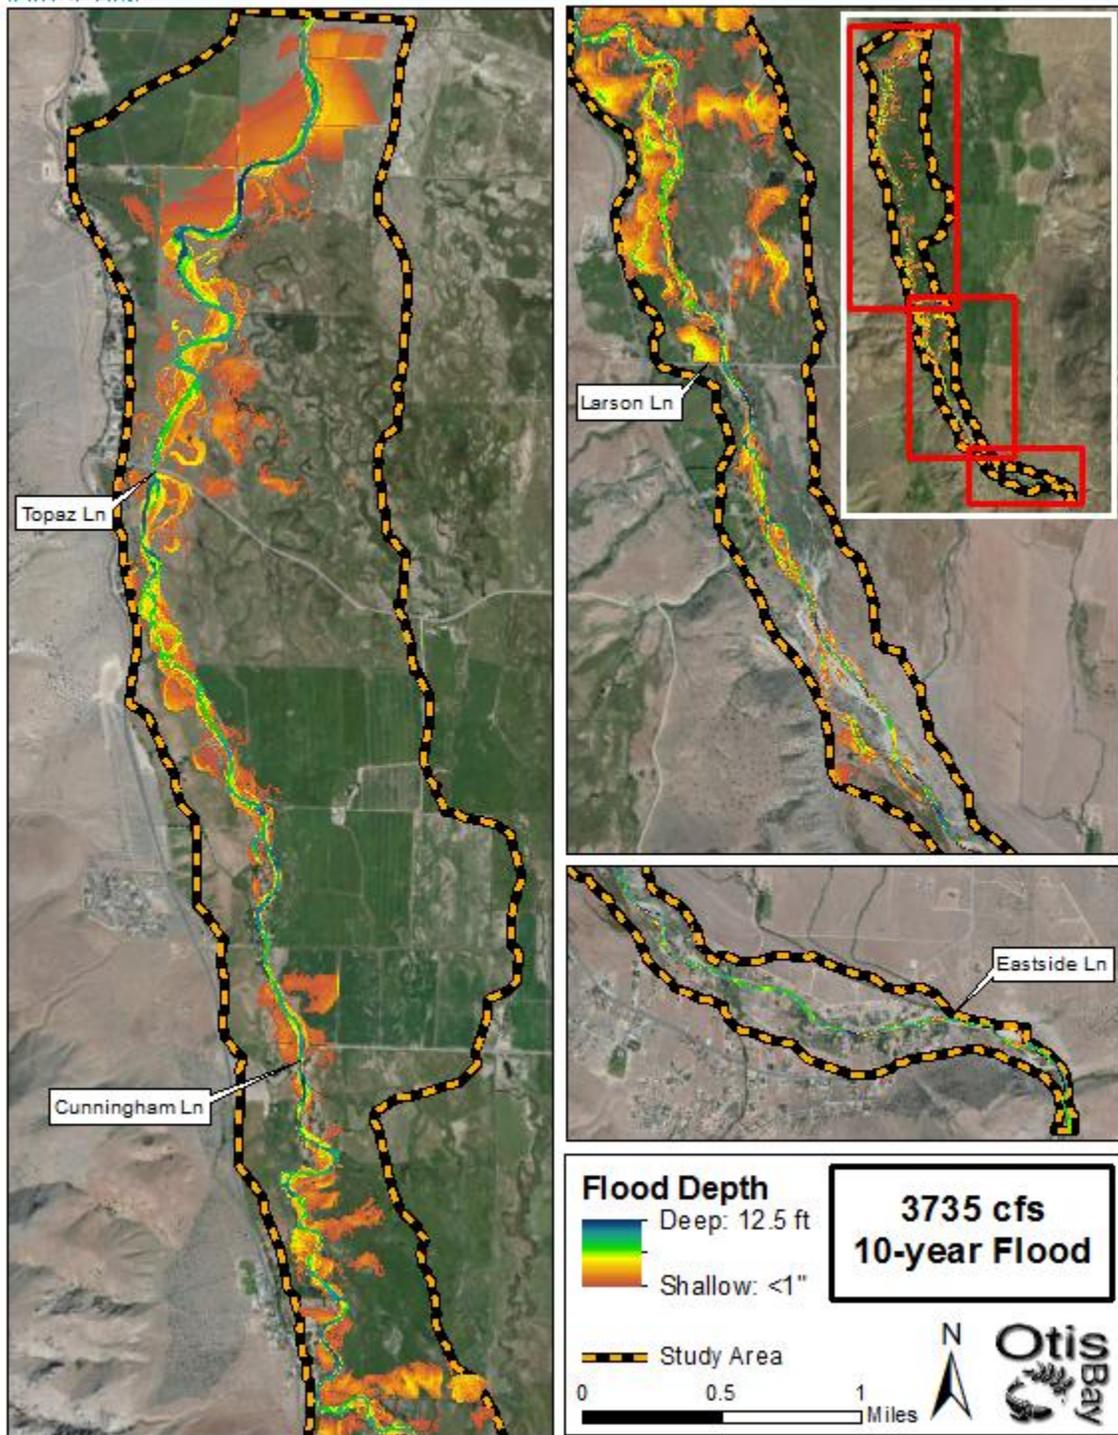
Figure 4-3. Modeled flood depths for a 10-year flood event (3,735 cfs) showing widespread floodplain inundation.
