Geophysical Assessment of the West Walker River through Antelope Valley

Prepared For

February 20, 2015

Prepared By

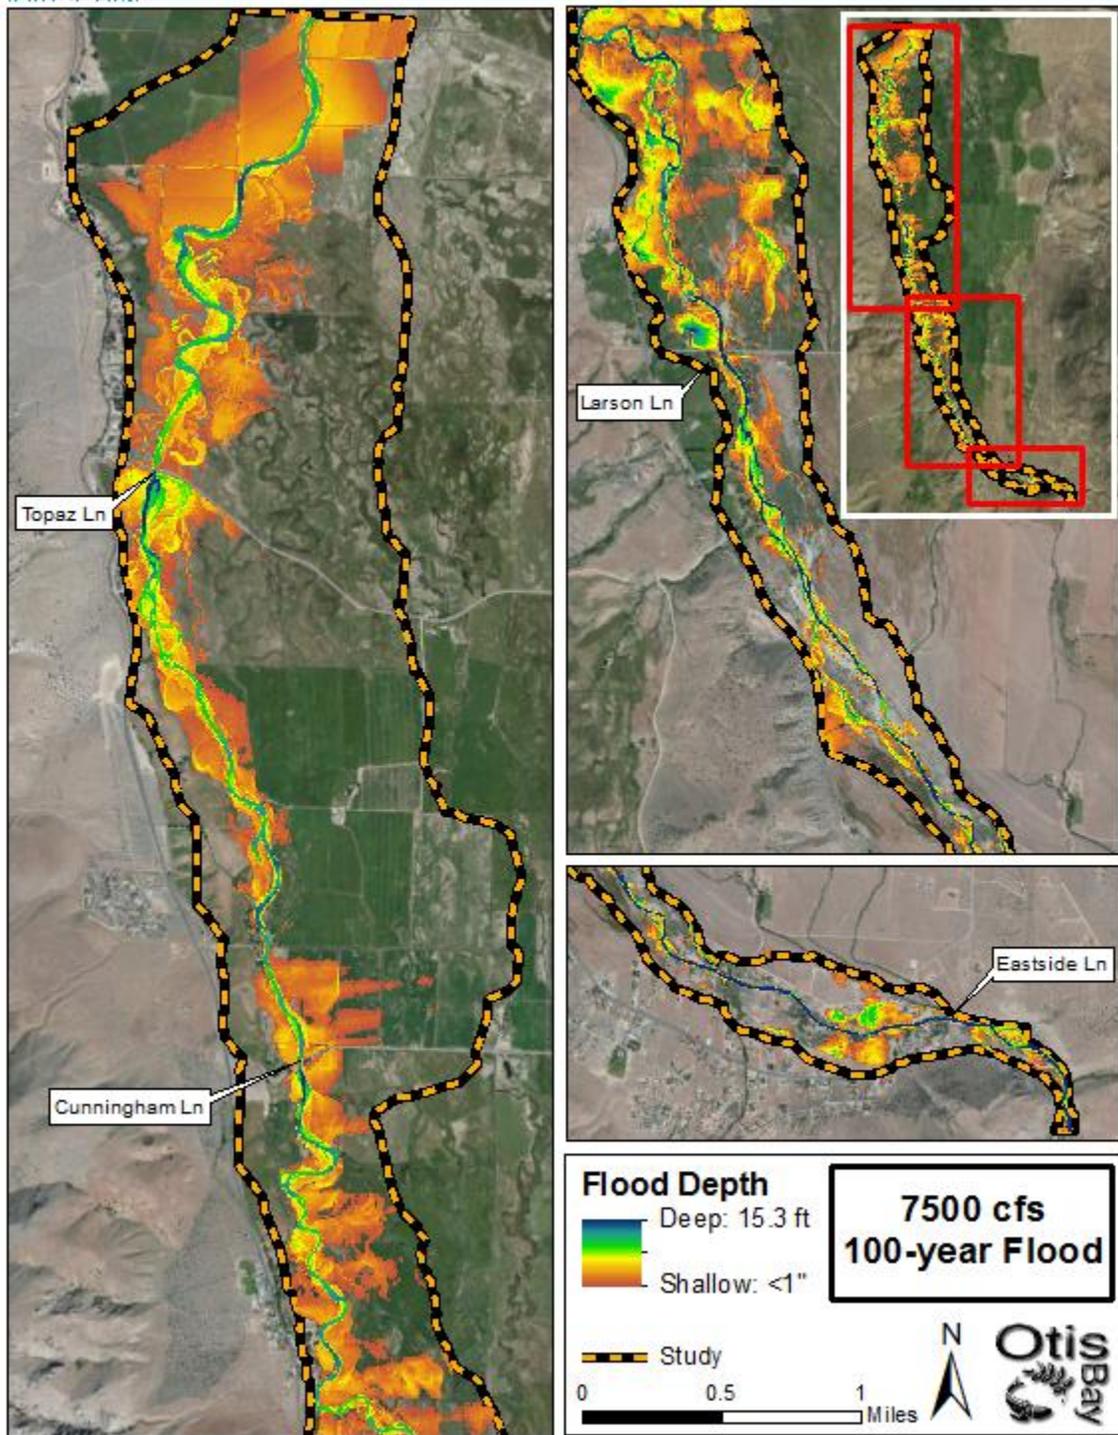
Figure 4-4. Modeled flood depths for a 100-year flood event (7,500 cfs) showing extensive floodplain inundation throughout the entire valley.

The analysis suggests that minimal overbank flow occurs through the town of Walker, except for small areas during extreme events, which is consistent with expectations, as the channel was constructed during emergency repairs in 1997 with the capacity to contain large floods. Downstream of the town of Walker and the Big Slough diversion, widespread floodplain inundation is observed during higher flow events (i.e., >10-year floods). Although the floodplain remains relatively narrow upstream of Larson Lane, downstream of Larson Lane the channel is well connected to the floodplain, where fewer channel modifications have been made aside from the built-up levees near the Larson Lane Bridge. Inactive channels become activated, and the inundation is widespread. The reach between Cunningham and Topaz Lanes consists of agricultural fields on the east side of the river, resulting in a substantially altered floodplain, with most of the overbank flow being confined to a narrow area directly adjacent to the river channel during moderate flows up to a 10-year flood event. Overbank flow becomes widespread again downstream of Topaz Lane, even in areas with agricultural fields. During a 100-year event, overbank flow is widespread throughout the valley, regardless of channel configurations in various reaches, as is expected for extreme events.

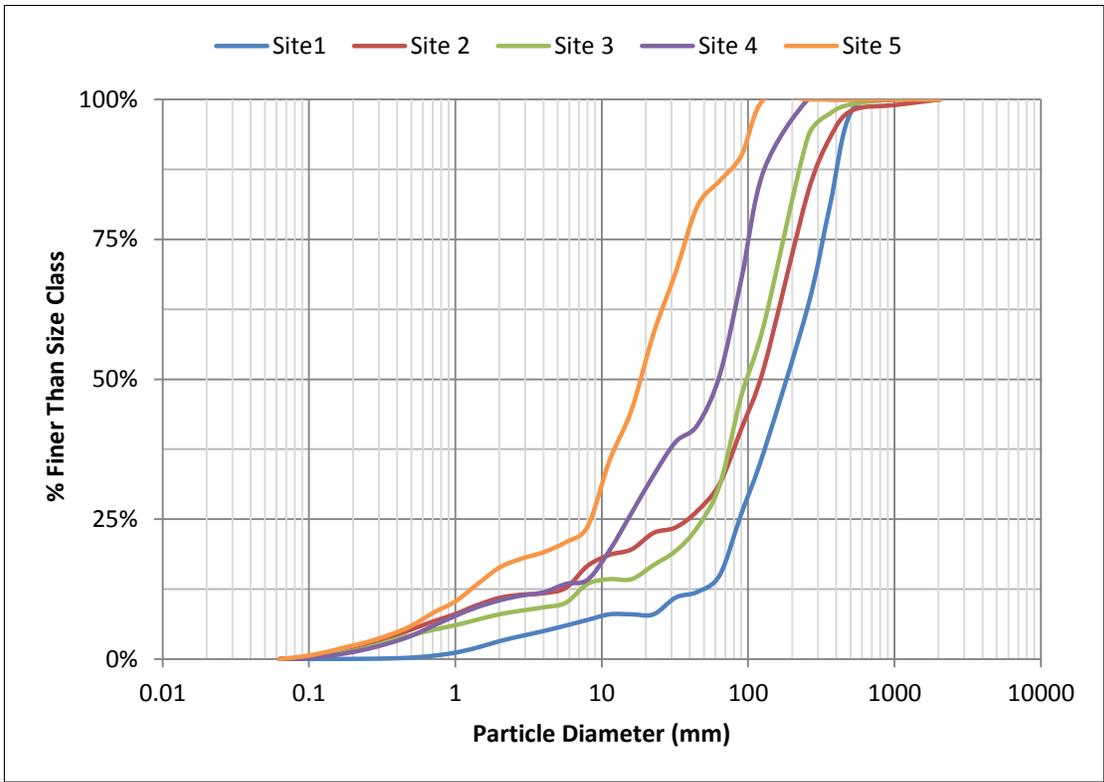
Figure 4-5. Particle size distribution curves for the five study sites.

As outlined in Section 2.2.2, Wolman pebble counts were conducted at the five study sites, in order to determine the streambed composition. Particle-size distribution curves were developed for each location, and the data were used to calculate particle diameter percentiles, D_p , so that further calculations could be performed based on streambed composition. The curves are displayed in Figure 4-5, and the percentiles are provided in Table 4-1. As expected, the median diameter of streambed particles is largest upstream, and decreases with downstream distance. This is typical in streams of this nature, with deposition of larger particles occurring upstream, and deposition of finer particles farther downstream. The particle-size distribution curves were used in the sediment transport calculations discussed in Section 4.2.2.

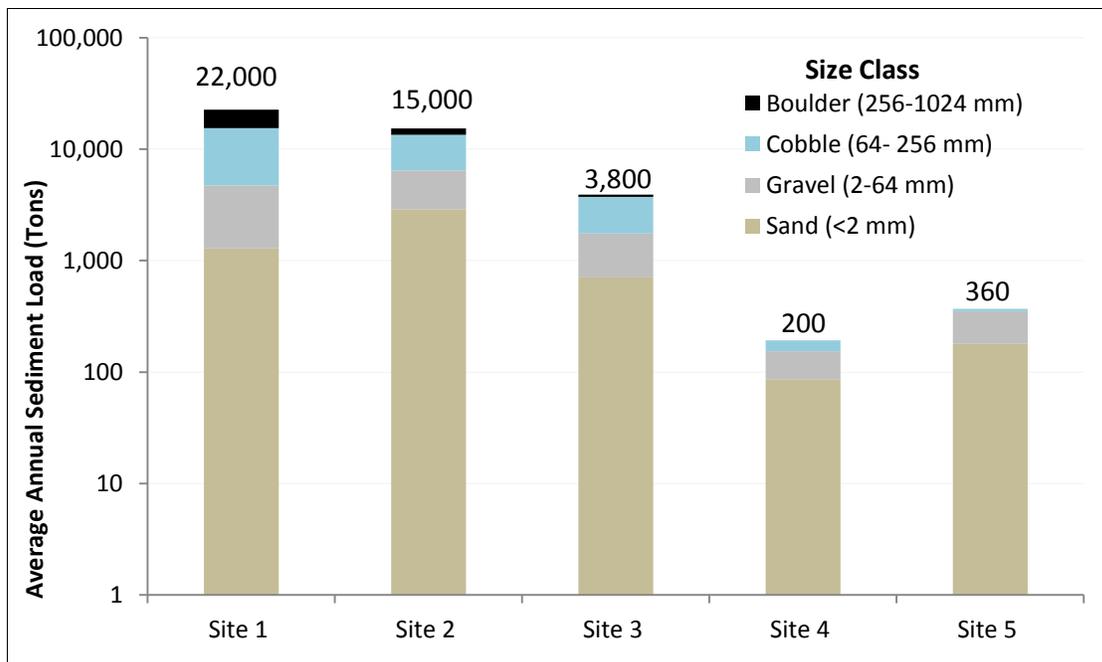
Figure 4-6. Average annual sediment loads for each of the five study sites which represent the various reaches through Antelope Valley.

The Parker bedload transport function was applied to data from each of the five study sites, and average annual sediment loads were determined based on hydrologic data from complete water years at the Coleville gage. Daily sediment bedloads were calculated and summed over complete water years, then averaged, in order to obtain the average annual bedload. The results of this analysis are summarized in Figure 4-6, where the particle size classes are broadly categorized as sand, gravel, cobbles, and boulders for simplicity.

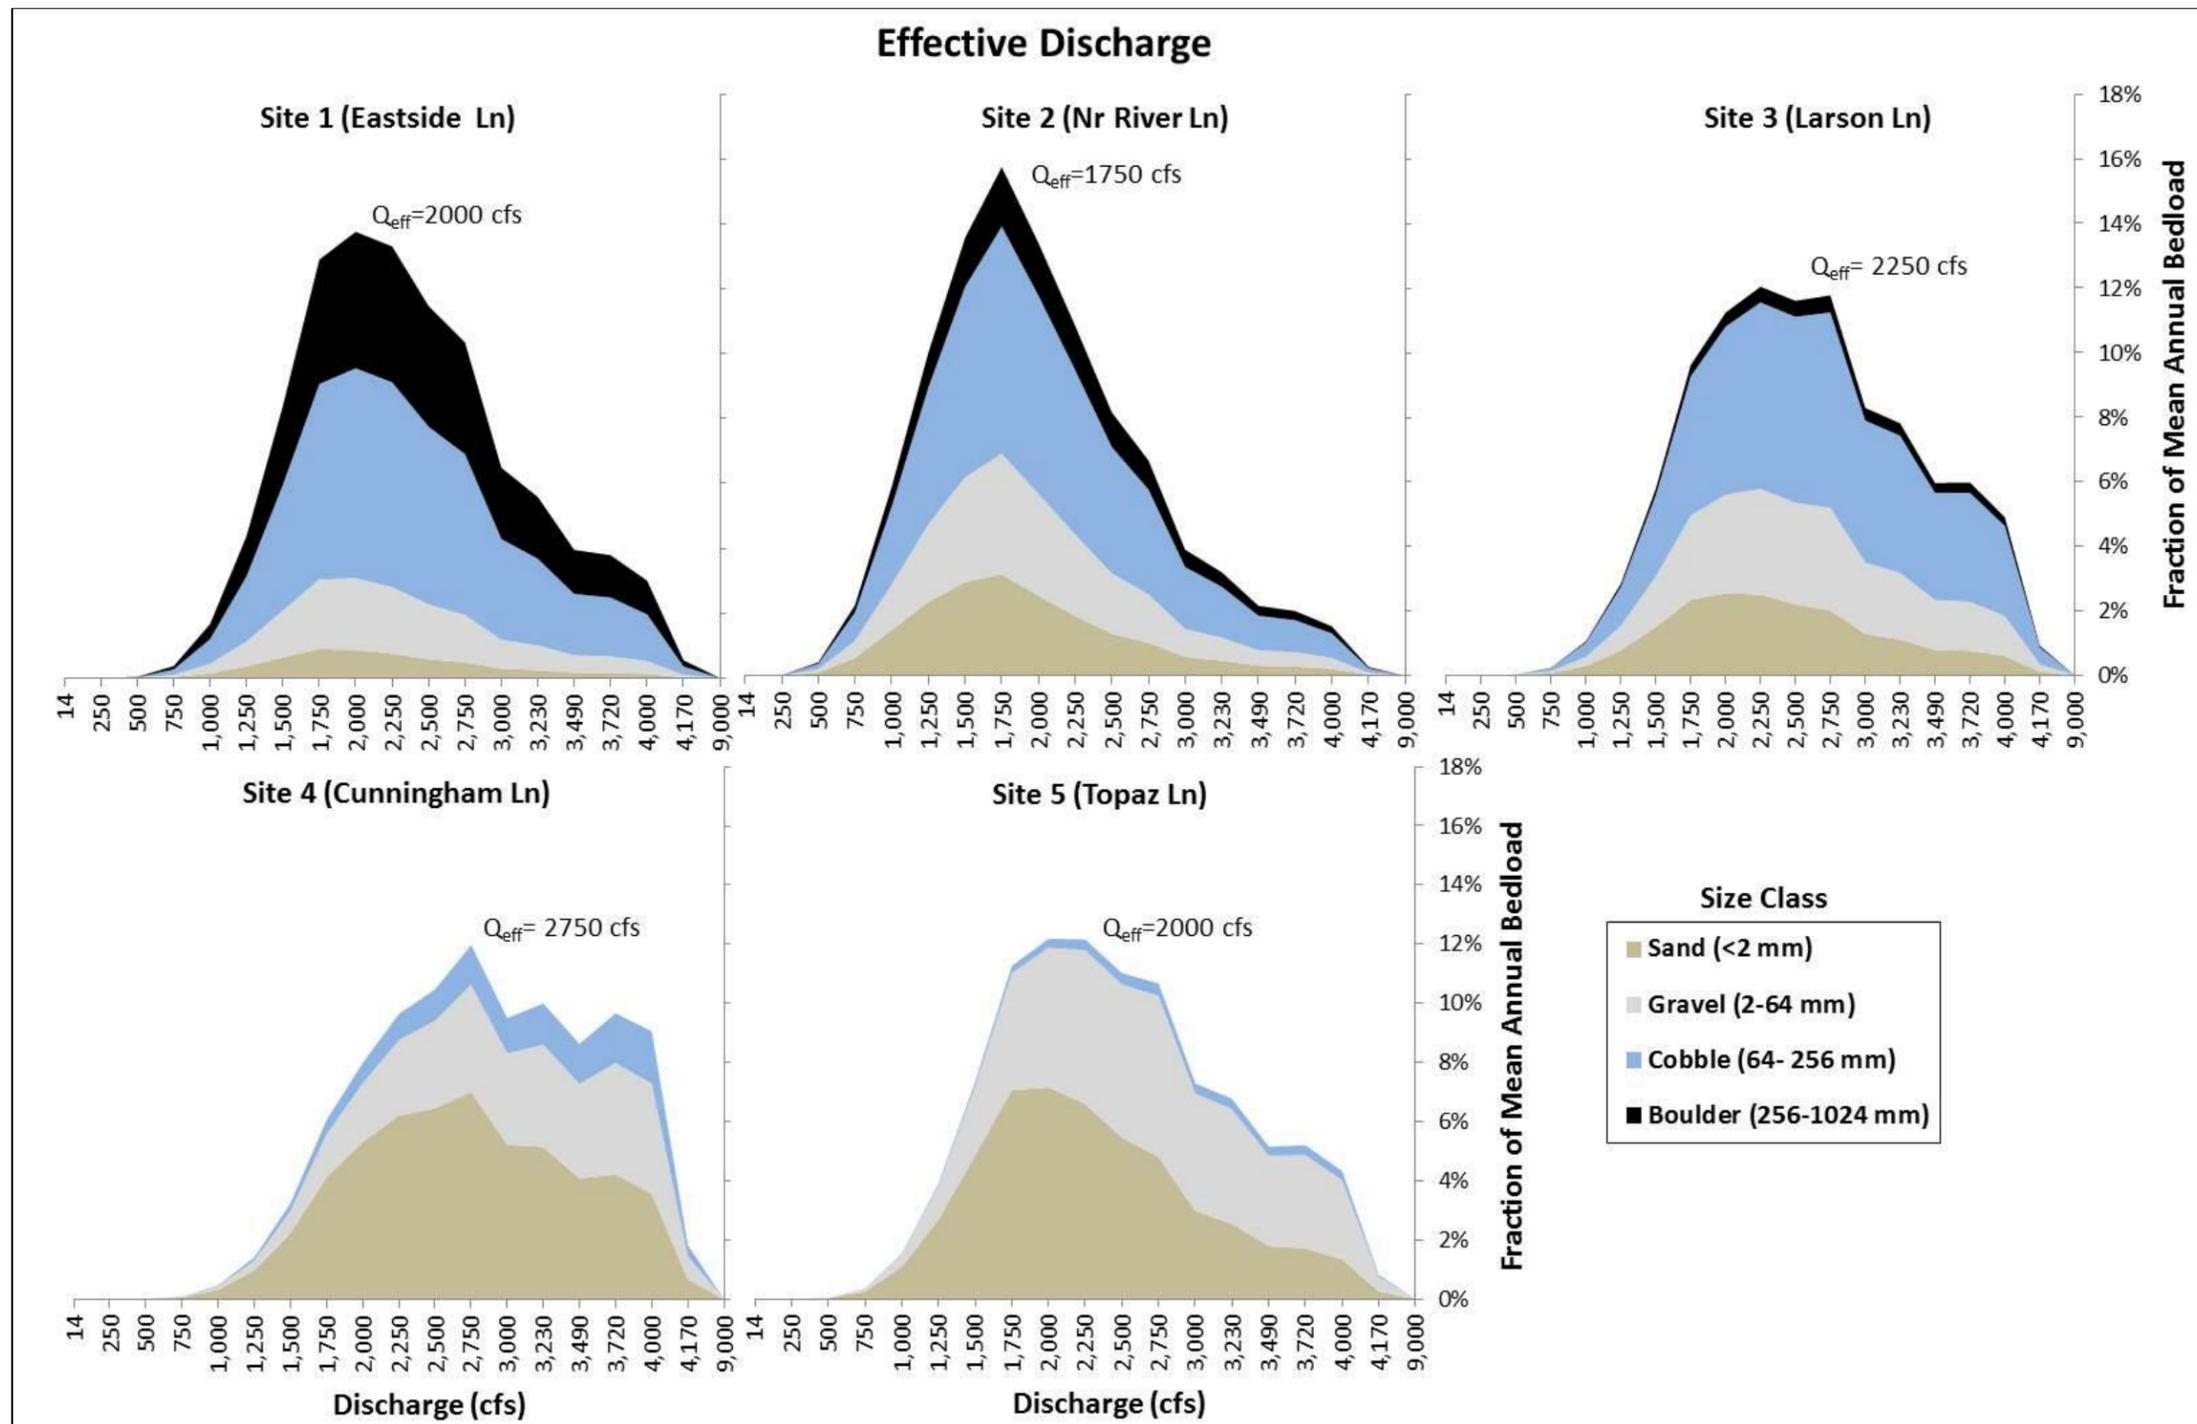
Figure 4-7. Effective discharges for the five study sites.

Effective discharges were determined for each of the study sites by combining the data obtained through developing the flow duration curve (Section 3.3.5), and the results from the bedload transport calculations. The effective discharge of a particular reach typically corresponds to geomorphically significant flows (Andrews, 1980; Andrews & Nankervis, 1995), and determining the effective discharge yields an understanding of the range of discharges that will likely transport a majority of the bedload. The effective discharges throughout the study area ranged from 1,750 to 2,750 cfs, and the results varied between the five study sites, as displayed in Figure 4-7. Once again, particle size classes are grouped into broad categories, for simplicity.

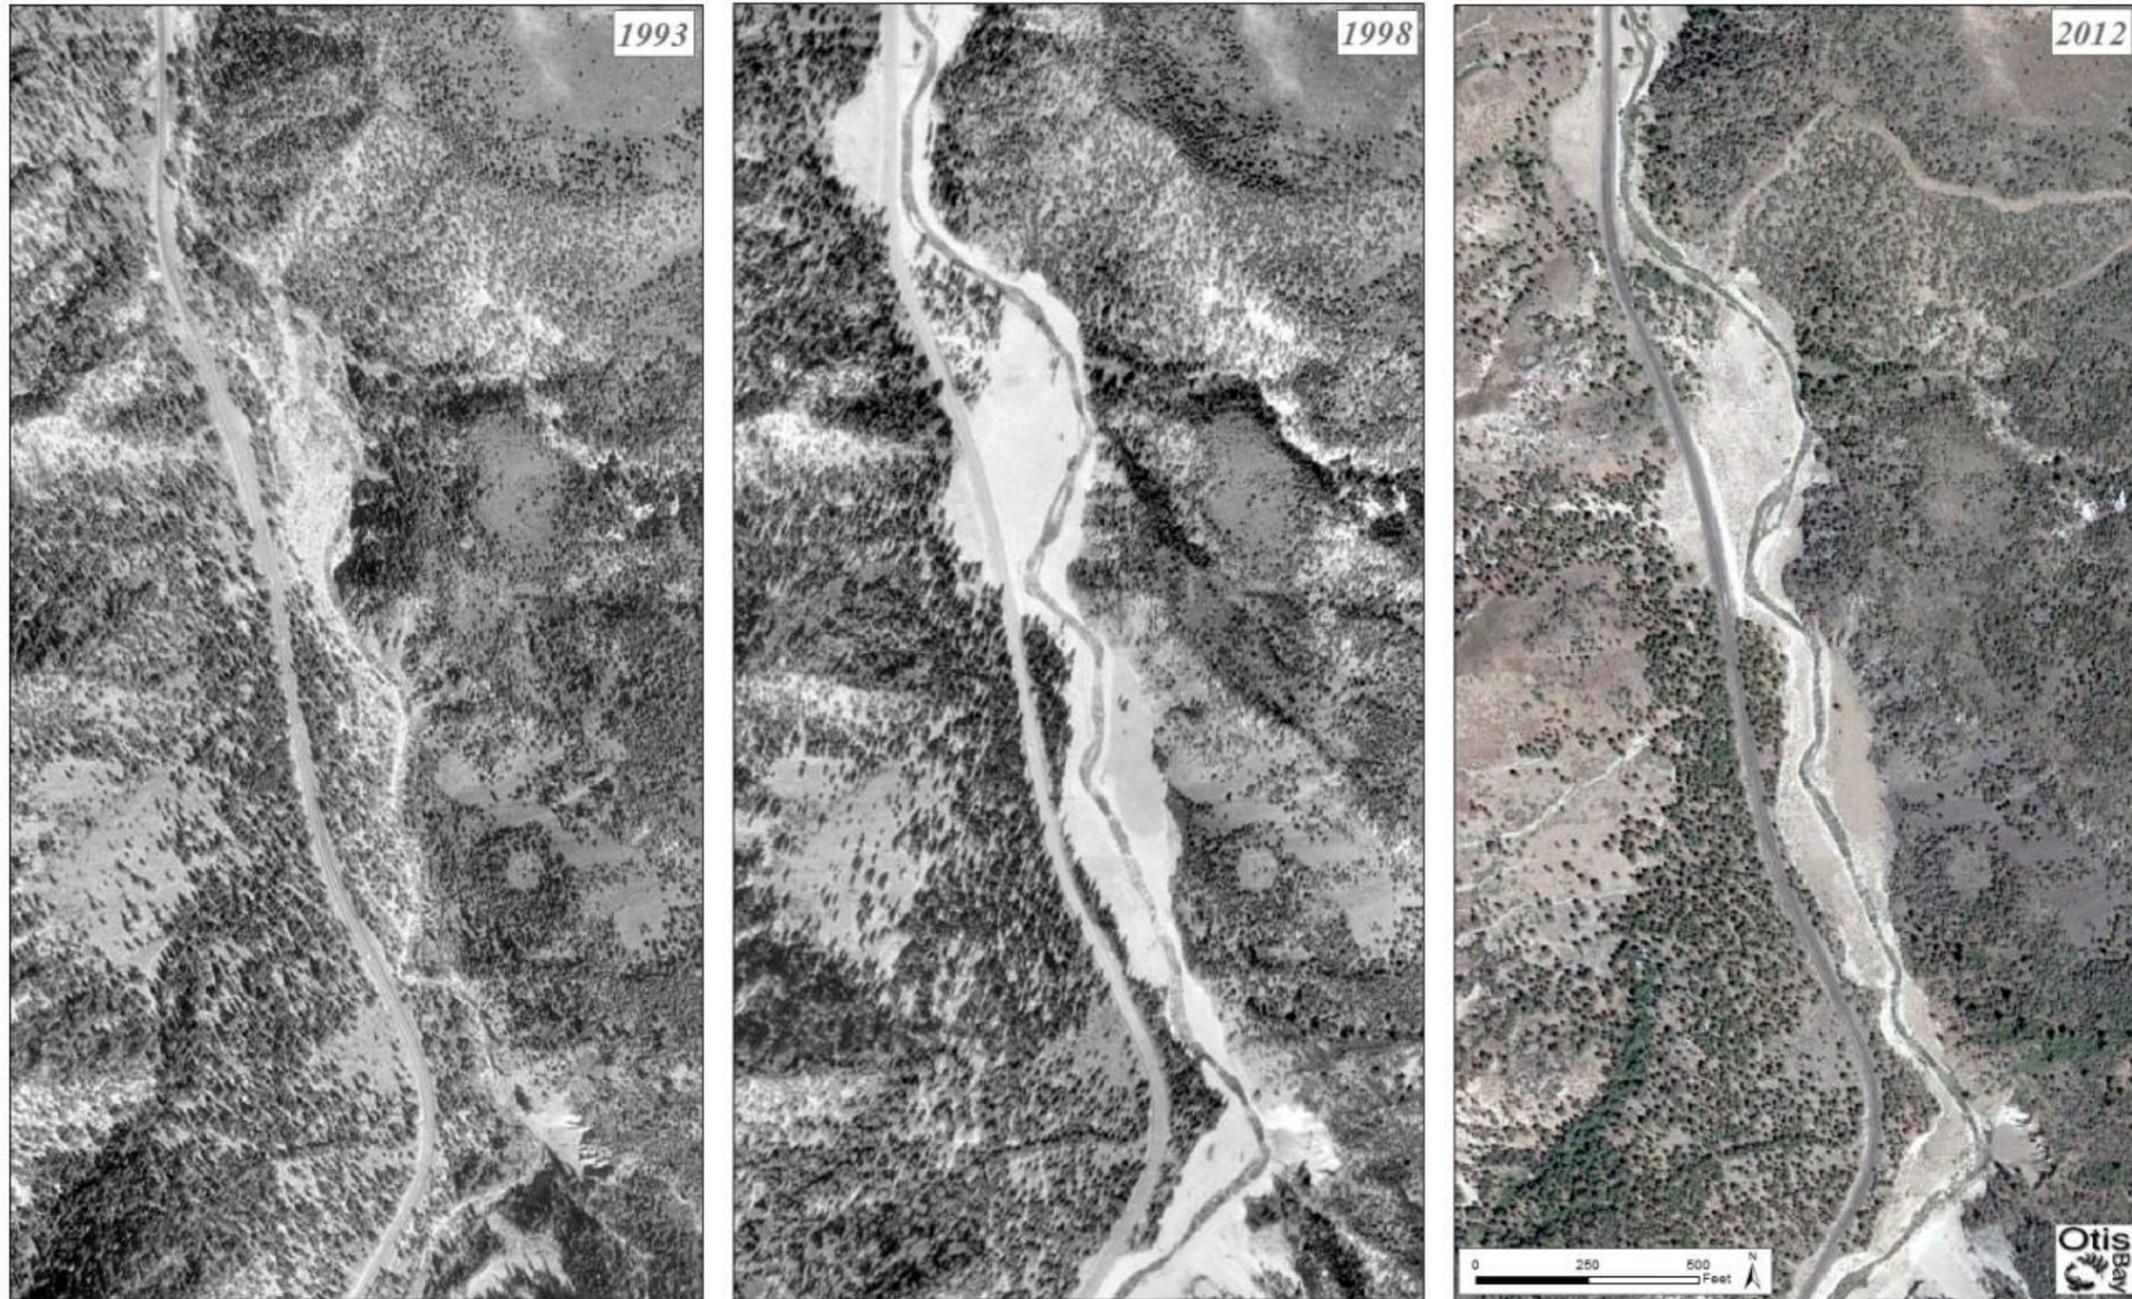
Figure 5-1. Aerial photos of a section of West Walker Canyon from 1993, 1998, and 2012 demonstrate the change in floodplain condition pre and post-flood (left and middle photos), and show no significant changes in riparian growth in 2012, 15 years after the flood. Photos obtained from Google Earth.

Whether or not post-flood channel work in West Walker Canyon actually increased erosion, entrainment and transport of sediment into Antelope Valley is unknown because in-depth sediment data have not been measured, but post-flood channel modifications likely increased the potential for these processes to occur. Low floodplain areas created during the flood, or left over from the pre-flood system appear to have been substantially cut off from ordinary high flow levels with post-flood channel modifications, and areas of deposition in West Walker Canyon were probably reduced. Floodplain areas would normally provide temporary storage of water and sediment, and would provide ideal conditions for growth of riparian vegetation. Instead, these areas appear to have been graded to elevations that were too high to create conditions for natural riparian vegetation establishment. Although the flood occurred more than a decade and a half ago, little riparian vegetation establishment has occurred (Figure 5-1). Although more study is needed, post-flood channel modifications on the West Walker River segment through West Walker Canyon may likely have increased fluvial sediment transport, allowing a majority of sediment from upstream sources to be carried by the river to locations farther downstream.

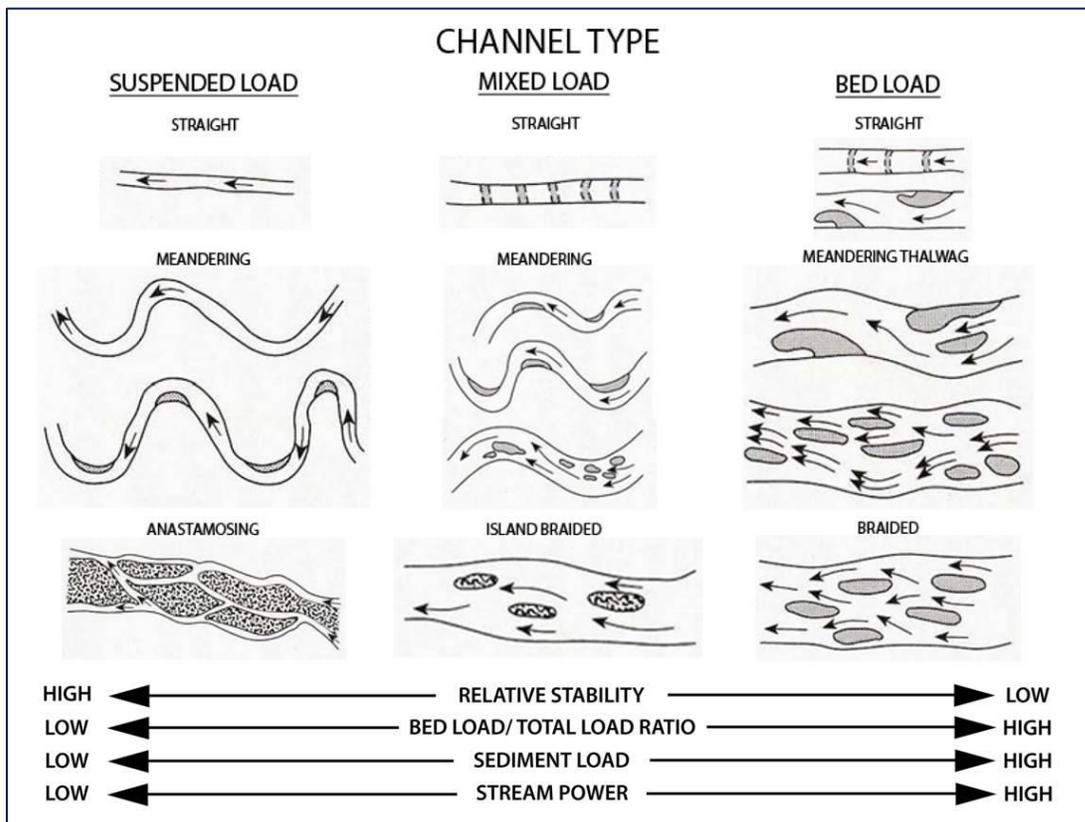
Figure 5-2. Illustration of the range of channel types that may occur (Knighton, 1998). In Antelope Valley the channel types range from high stream power, high bed load, and low stability channel types near the town of Walker to a lower stream power, mixed load, meandering channel near Topaz Lane.

Channel type is a product of the hydrologic characteristics, physical characteristics, and sediment supply (Figure 5-2). At the mouth of West Walker Canyon, where the West Walker River enters Antelope Valley, a constrained alluvial fan has been deposited. Relict distributary channels are visible in older aerial imagery. These channels and fan are a result of flowing water pushing sediment over the fan and building the fan into the valley, similar to the process of a delta forming where a stream channel flows into a lake. The toe of the fan is located near Larson Lane. Downstream of Larson Lane the valley slope flattens, the channel type changes, bed sediment becomes finer and the topography reflects a valley setting rather than an alluvial fan.

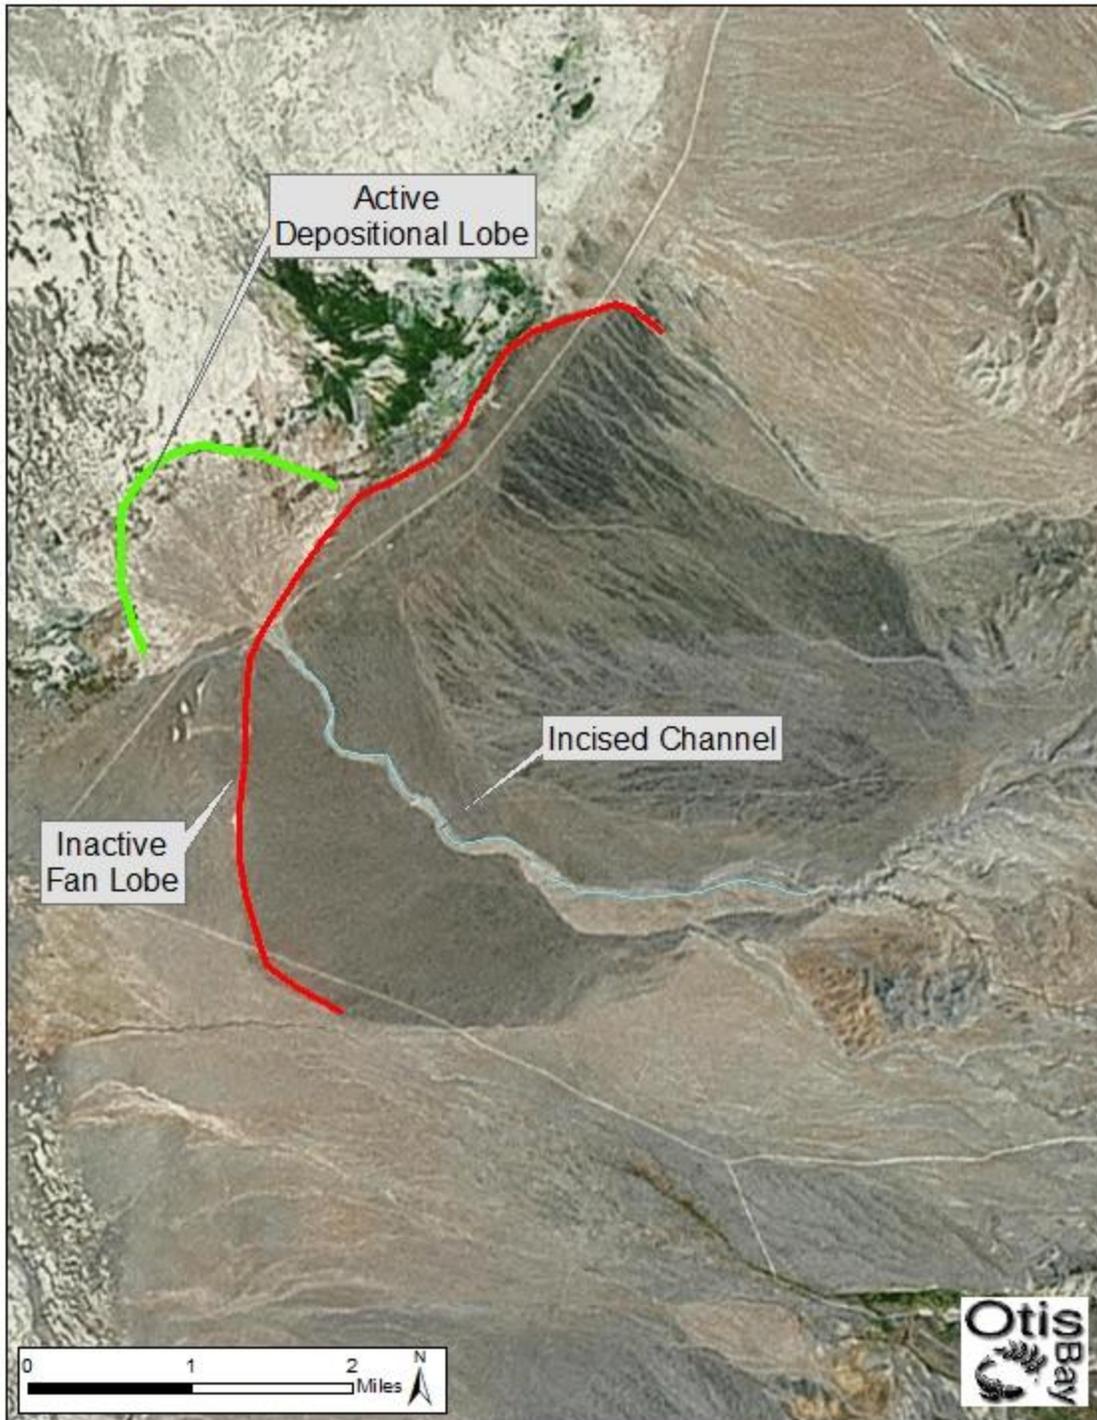
Figure 5-3. Naturally occurring incised alluvial fan in northeastern Nevada. The active depositional lobe has migrated beyond the toe of the fan.

Currently, the active depositional lobe of the alluvial fan is migrating downstream because the channel was artificially incised through the town of Walker by emergency channel modifications made by USACE after the 1997 flood. For a variety of reasons, depositional lobe migration can occur in natural systems. For example, channel incision can begin to occur on an alluvial fan after some significant event such as an abnormally large flood or fault slip, and the newly entrenched channel changes from a distributary, depositional environment to an erosional, transport environment. Typically, the resultant processes happen slowly, and the effects are propagated downstream over a number of years. An example of a naturally incised alluvial fan in northeastern Nevada is provided in Figure 5-3. This image shows the active depositional area of the fan has migrated downstream due to an incised channel that has formed on the original fan lobe.

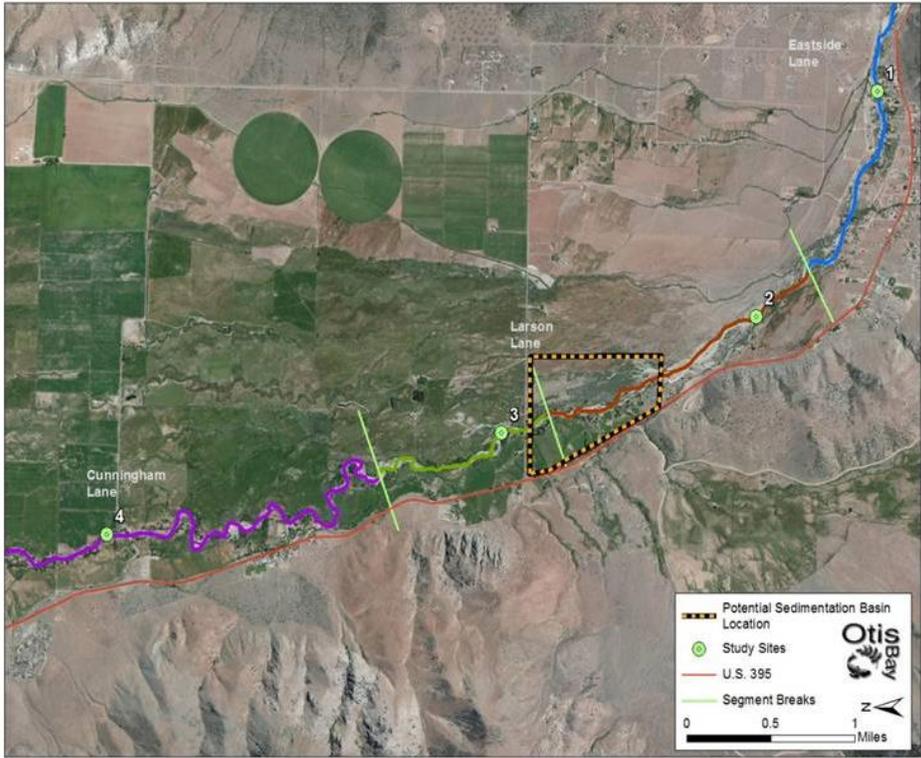
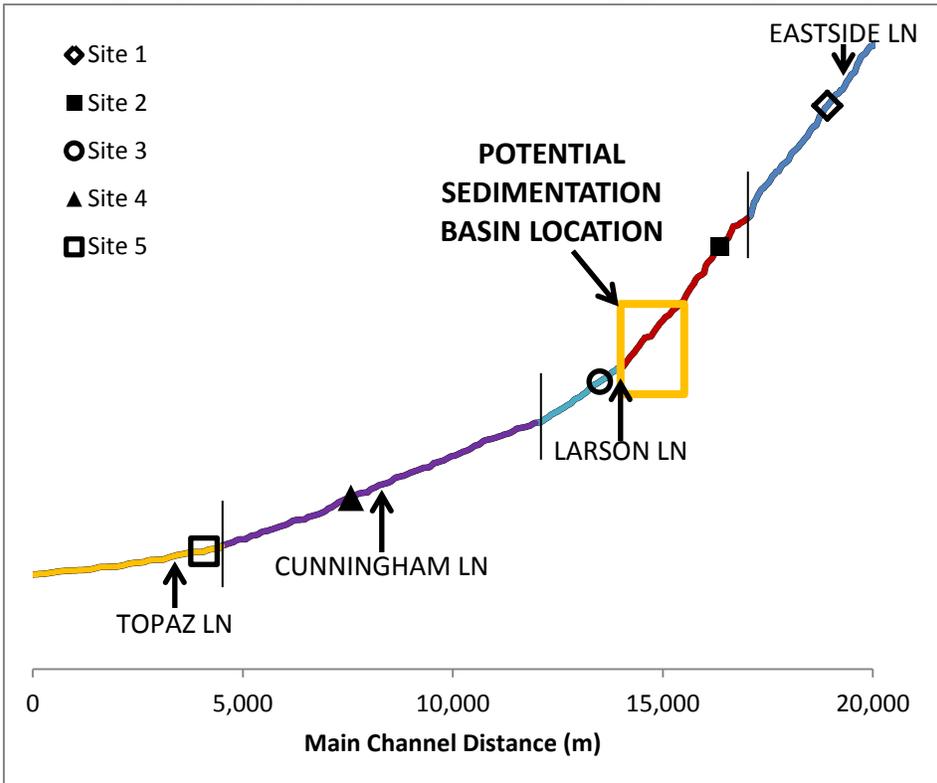
Figure 6-1. Potential location of a sediment catchment basin on the West Walker River near Larson Lane.

- *Design and construct a sediment collection basin. Partners could be instrumental in sharing the cost. For example, this basin could reduce sediment filling Topaz Reservoir and could generate opportunities for cost-share partnerships, or a sand and gravel operator might find sufficient economic value in the sediment as a marketable product.*
