**Subject:** ENG – Trip Report  
Fort Independence, California  
March 20, 2012

**Date:** April 30, 2012

**PURPOSE:** The primary purpose of the field review was to assess the Oak Creek Watershed as a potential field demonstration for Stream Restoration and Streambank Soil Bioengineering Technical Training Workshop that is scheduled for October 2012. A second goal was to assess conditions in the watershed and provide general suggestions to stabilization work.

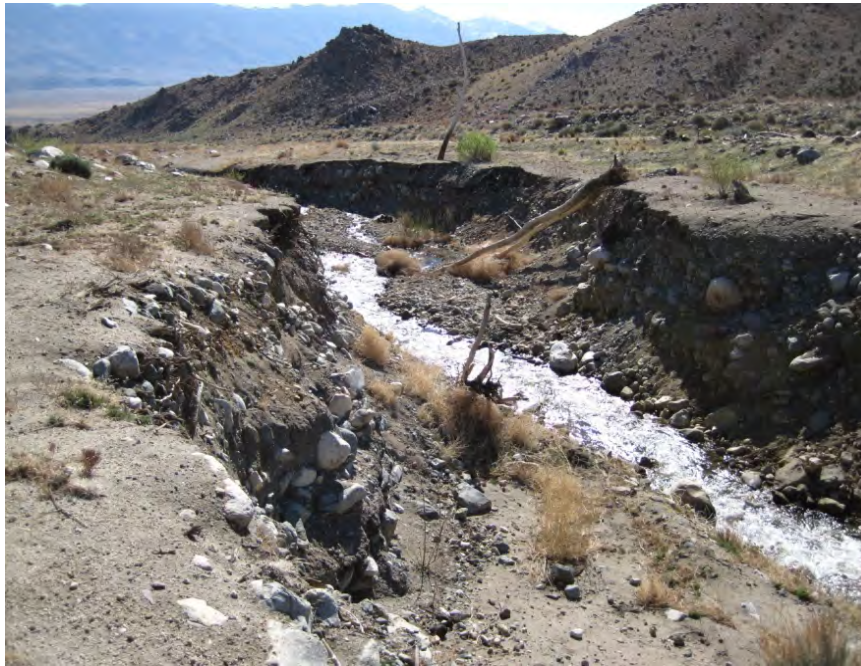
Figure 1 (Upper watershed area of Oak Creek (North Fork))

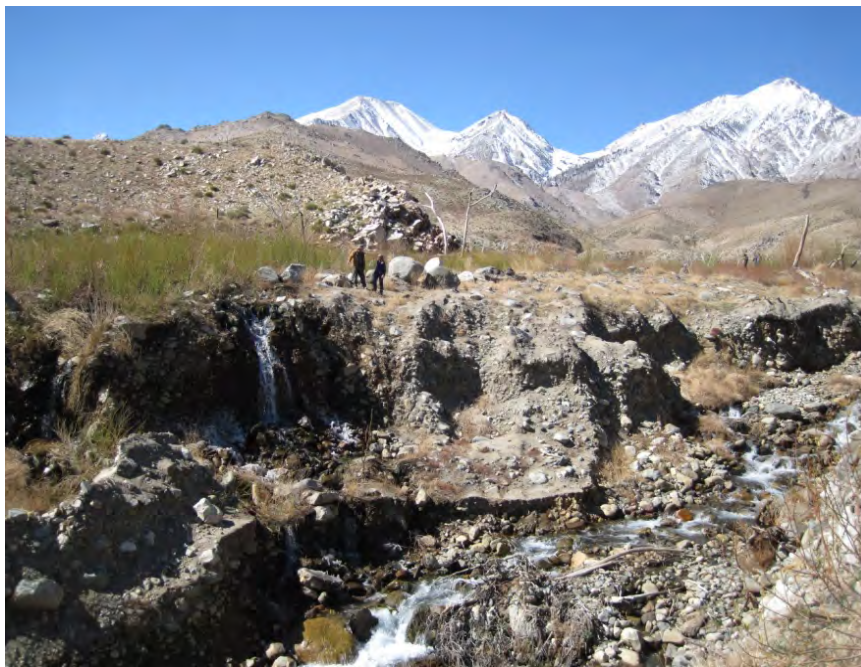
Figure 2 (Upper watershed area of Oak Creek (Middle Fork))

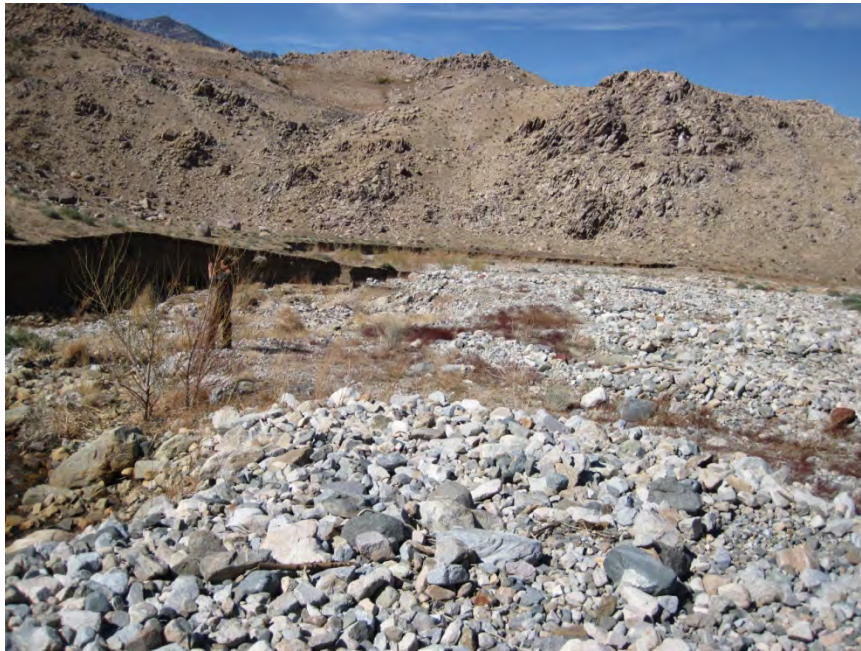
During the subject trip, areas were visited where significant deposition had occurred in the channel. This situation was particularly evident in the upper portion of the watershed. In some of these areas, the channel was nearly filled with cobbles and gravels. An example of this is shown in (Figure 4). Not only is this deposited material posed to remobilize during the next high water event, but it is causing more material to be introduced into the system. Stream flow is forced to the toe of steep slopes near valley walls. The resulting erosion is destabilizing the slopes. Slides may introduce significant sediment material which can adversely impact lower reaches.

Figure 4 (Area where deposition has filled channel and forced flows against bank)

Adequate funding is not available to address this issue at the scale that would be required for it to be addressed on an impact scale. The group discussed economical solutions that have been used in other areas. One to push the larger deposited cobbles against the eroding bank. This is sometimes referred to as the ‘Embankment Bench Method’ (NEH 654.14K). Drainage from the bank would flow through the granular material. Areas where the channel impacted the bank would be filled and a new channel formed. This ‘quick-and-dirty’ approach is shown in (Figure 5). Adventitiously rooting live material can be incorporated into this bench. An appropriate source could be some of the willow clumps that are observed in portions of the channel.

If the decision is to pursue this method in order to address areas in the upper watershed, it is suggested that the stakeholders are made aware that the channel will still be active. There are significant sediment pulses being delivered from areas above these sites which may fill the channel again. In addition, the material that is being used to ‘protect’ the eroding bank is from the channel. If the material moved before, it will likely move again during a high event. The benefit provided by this approach is that by moving the coarse material towards the edge rather than leaving it in the channel, it will take a larger event to move it and the stress on the bank is reduced.

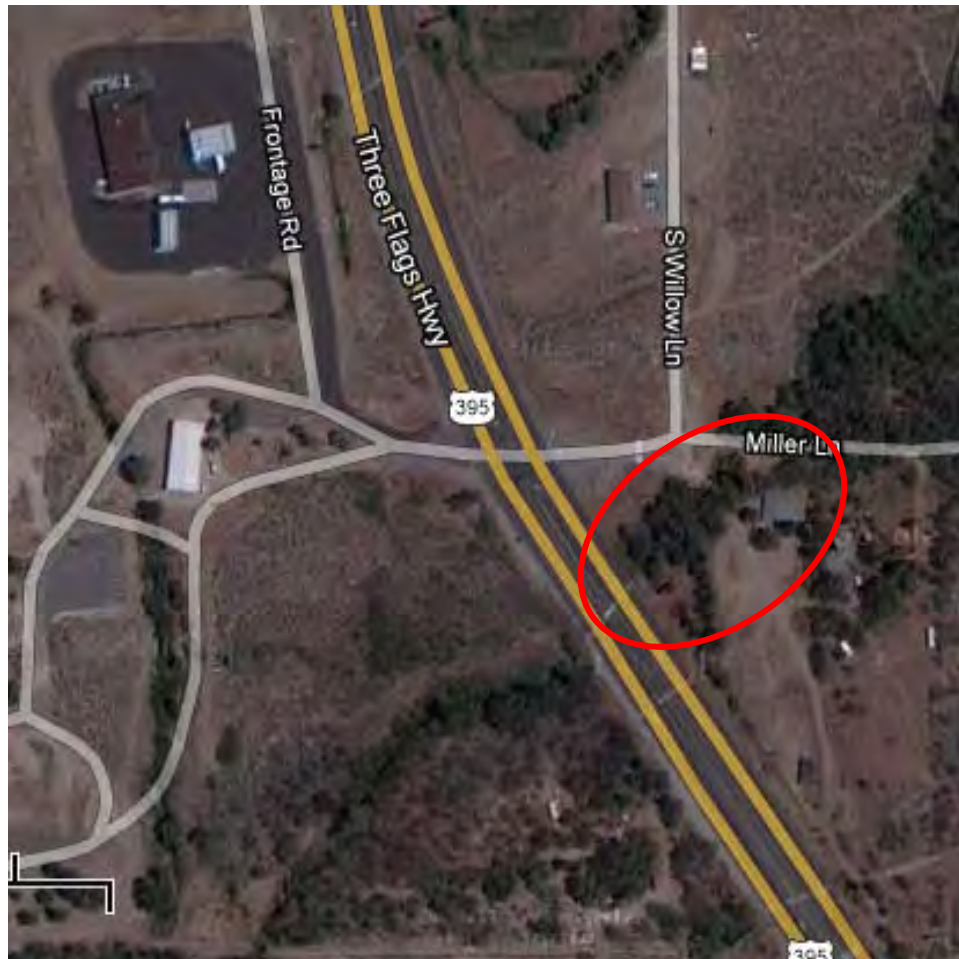
**WORKSHOP SITE:** The potential workshop site is located in below Route 395 and on Tribal land. An aerial view is shown in (Figure 6). It is located in a visible area and is also near Tribal offices. It would be suitable for recreational and education purposes. The area had been impacted by the sediment flows resulting from the 2008 event. However, areas above Route 395 are regularly dredged and it is expected that significant additional sediment inflows are unlikely as long as this upper area is maintained. Since the reconstruction of the upstream diversions and monitoring, the discharge is very much controlled as well. The upper portion of the site begins at Route 395 at a single 30-inch CMP. The lower portion flows under a private drive through twin 24-inch CMPs. As a result, the grade is fixed.

Figure 6 Aerial map of potential workshop area (circled))

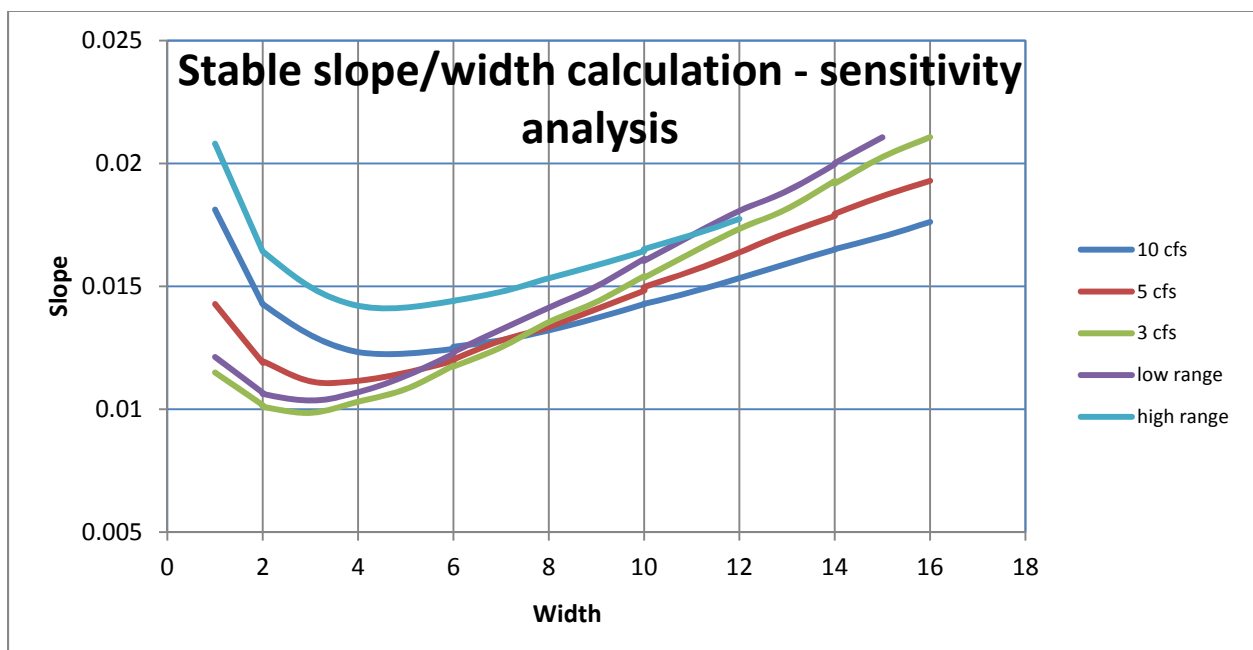
While large slugs or debris flows of sediment can clog the channel and cause avulsions, the channel does appear to be able to transport inflowing sediment load under equilibrium conditions. Field observations during the subject visit indicate that the lower reaches can adequately transport incoming sediment load and are relatively stable when the banks are vegetated. Calculations made using the HECRAS Hydraulic Design routines as shown in (Figure 7) supports this field assessment. This analysis does not indicate that the existing channel is stable but that the current dimensions can adequately transport the inflowing sediment under normal conditions.

Figure 7 (Stable width/slope calculations and sensitivity analysis)

The analysis shown in (Figure 7) also indicates that excessive inflows of sediment will likely clog the channel. This could adversely impact the project area as it did after the 2008 event. However, it appears that active dredging and channel clearing is currently underway in the immediate area upstream of Route 395 and that this will likely arrest large pulses of sediment before they impact the workshop demonstration site.

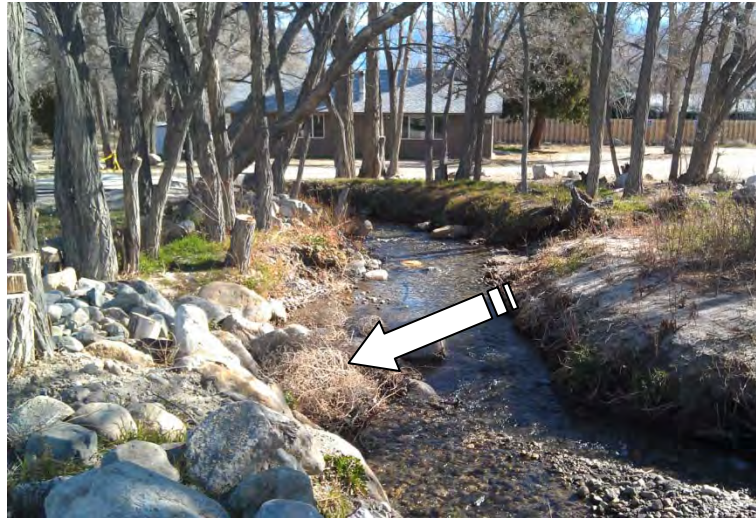
**Fascine Toe:** A portion of the channel should be narrowed and the channel bend softened. The center bar / in-channel material can be used for this part of the project. This area is shown in (Figure 15). A fascine is proposed at the toe of this area. It will provide immediate protection that gets stronger with time as the cuttings root and grow. The fascine should be constructed with live willow cuttings as previously discussed. This area of the bank is under direct stress which provides for a good demonstration of this traditional soil bioengineering practice. Fascines are

Figure 15 (Area for reshaping and fascine installation)

The grading and realignment should be done with an excavator prior to the class. The fascine can be constructed and installed with shovels and sledge hammers using student labor during the class. String and dead stout stakes are required to secure the material.
