**OAK CREEK WATERSHED**  
**STREAM STABILITY ASSESSMENT AND RESTORATION**  
**RECOMMENDATIONS REPORT**

**INYO NATIONAL FOREST**

**Prepared by USFS Hydrologist Craig Oehrli**

**August 2015**

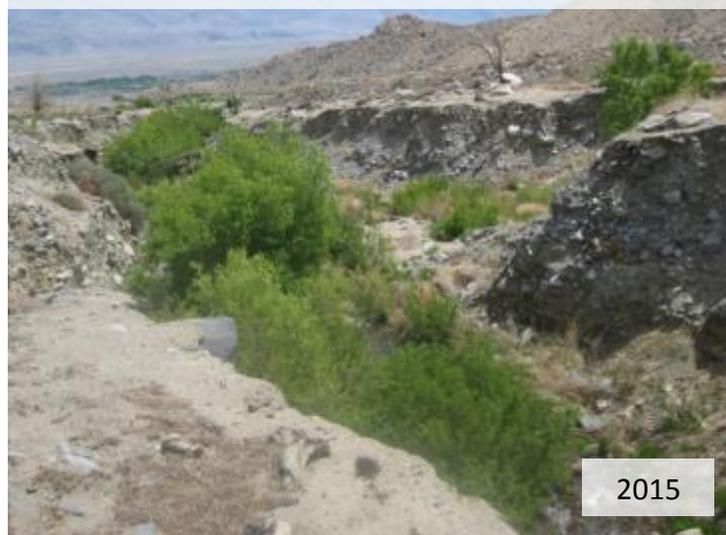
North Fork Oak Creek riparian vegetation regrowth

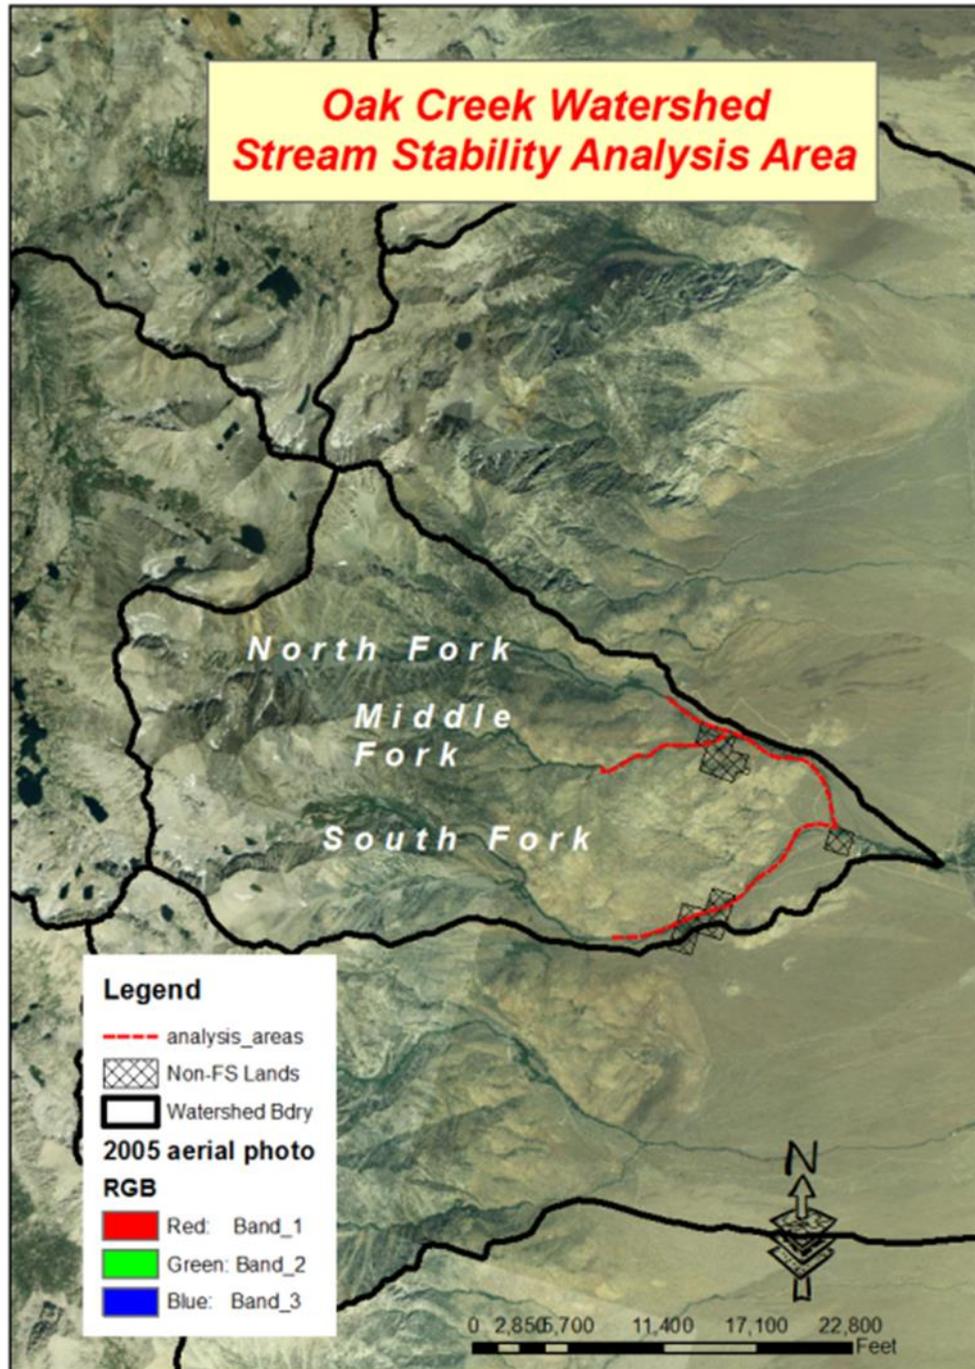
FIGURE 1 – Oak Creek watershed and stream stability analysis areas. These areas were chosen because they have depositional zones that are as “a canary in a coal mine” so-to-speak. These areas are the best examples of stream instability in response to a disturbance, then can turn around and exhibit forms indicative of stream recovery.
